## Pipe type and seismic performance in Christchurch, New Zealand

To cite this article: S Toprak *et al* 2020 *IOP Conf. Ser.: Mater. Sci. Eng.* **800** 012042

# Pipe type and seismic performance in Christchurch, New Zealand

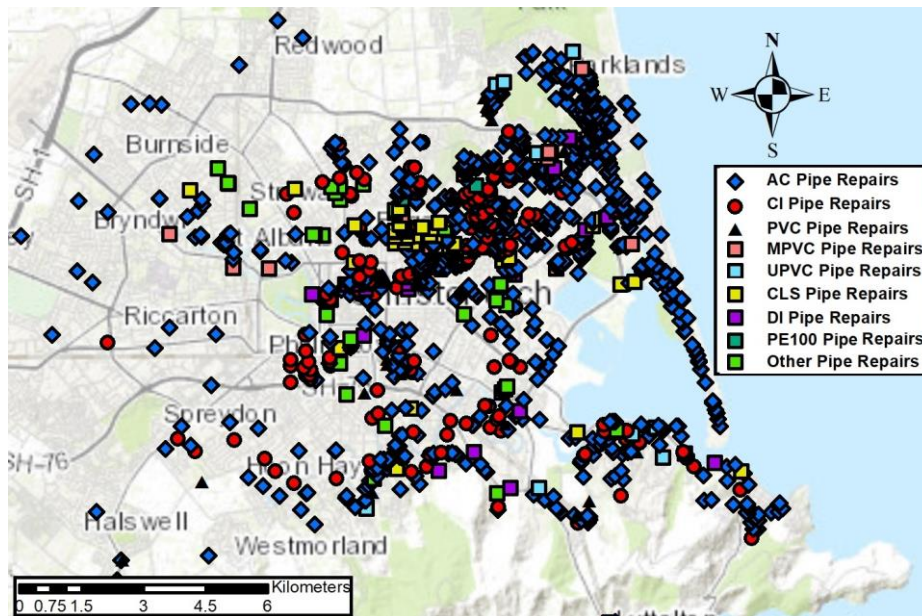
**Figure 2.** Pipeline repairs in Christchurch with respect to pipe material

The 22 February 2011 earthquake caused substantial damage to the pipelines (Figure 2). The total number of repairs to main pipelines was 1502. About two thirds of the damages occurred on AC pipelines. As shown in Figure 3, although service was provided to about half of the households a few days after the earthquake, the recovery took significant time. The City applied “boil water notice” to whole Christchurch between February 23<sup>rd</sup> and April 8<sup>th</sup>, 2011 to protect residents against disease. The “boil water notice” is about to treat tap or tanker water by boiling before any use for drinking, brushing teeth or preparing food.

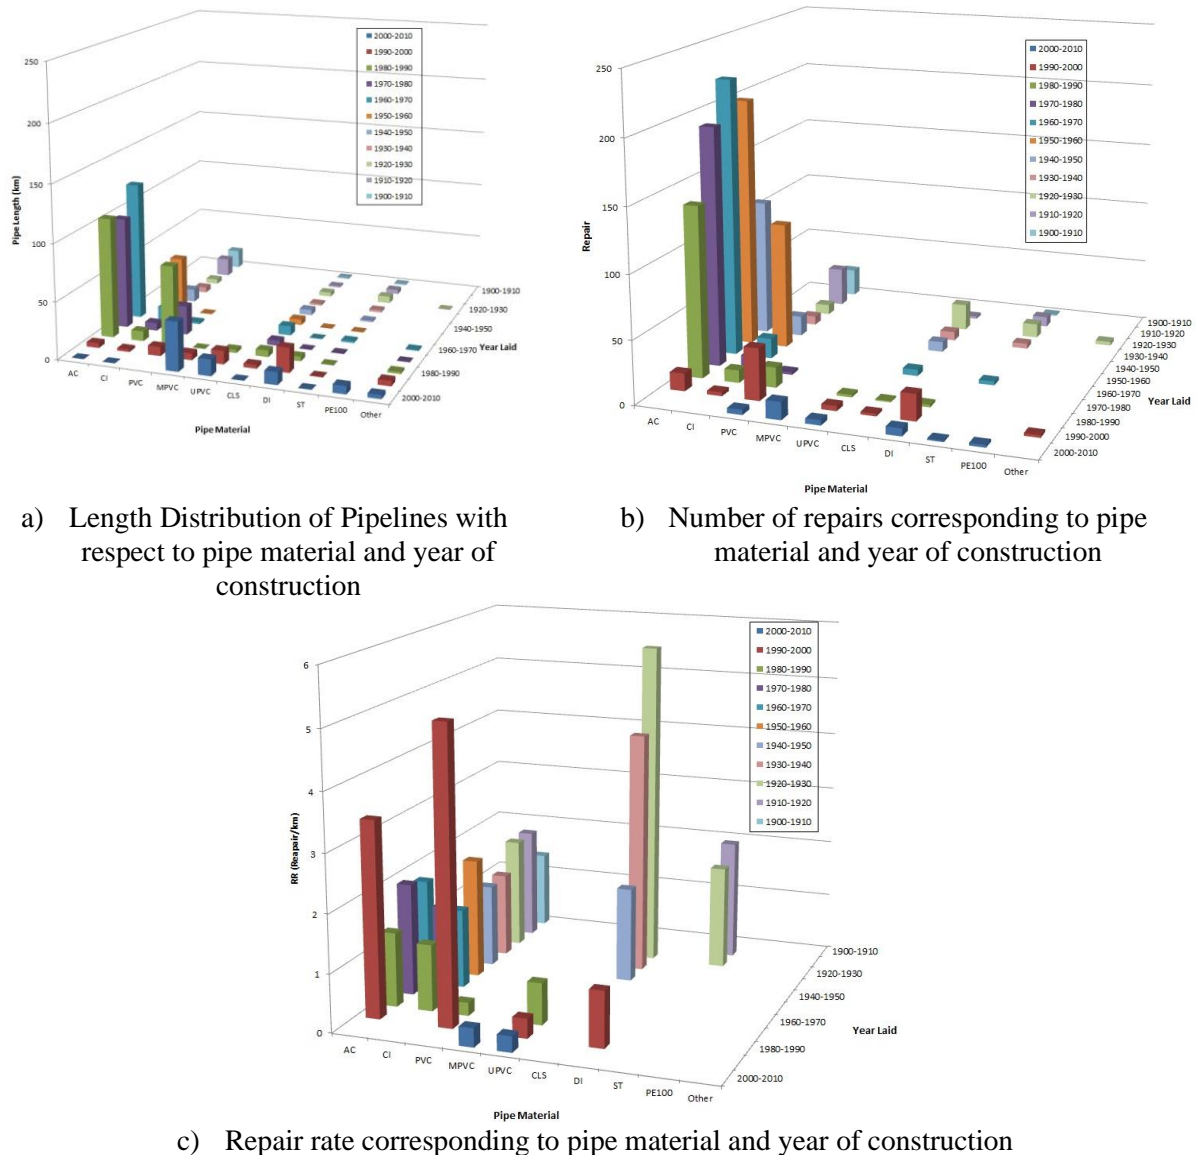
**Figure 4.** Pipelines in liquefaction zone with respect to pipe material and year of construction

Geographical information systems (GIS) were utilized during the preparation of the database and analyses stage. Figures 4a, 4b, and 4c show, respectively, the length in km, number of repairs and repair rate of pipelines in the liquefaction zone with respect to pipe material and year of construction.

Most of the pipelines were constructed after 1940s. Installments of AC and CI pipelines stopped even before the earthquake. Polyethylene pipelines were the preferred pipe type for the replacements after the earthquake. Repair rate (RR) is commonly used in pipeline damage assessment studies and shows the number of repairs divided by the length of the pipelines in the same area. In essence, the number of repairs are normalized by length of pipelines. It should be noted that not all RR values are shown in Figure 4c, because a screening criteria was applied. The fidelity of the RR statistics is sensitive to the pipeline length sampled and number of repairs observed within a given sampling length. Hence, in this study, the screening criteria developed by O'Rourke [3] were used during the RR analysis of pipeline damage to ensure fidelity of the RR comparisons.

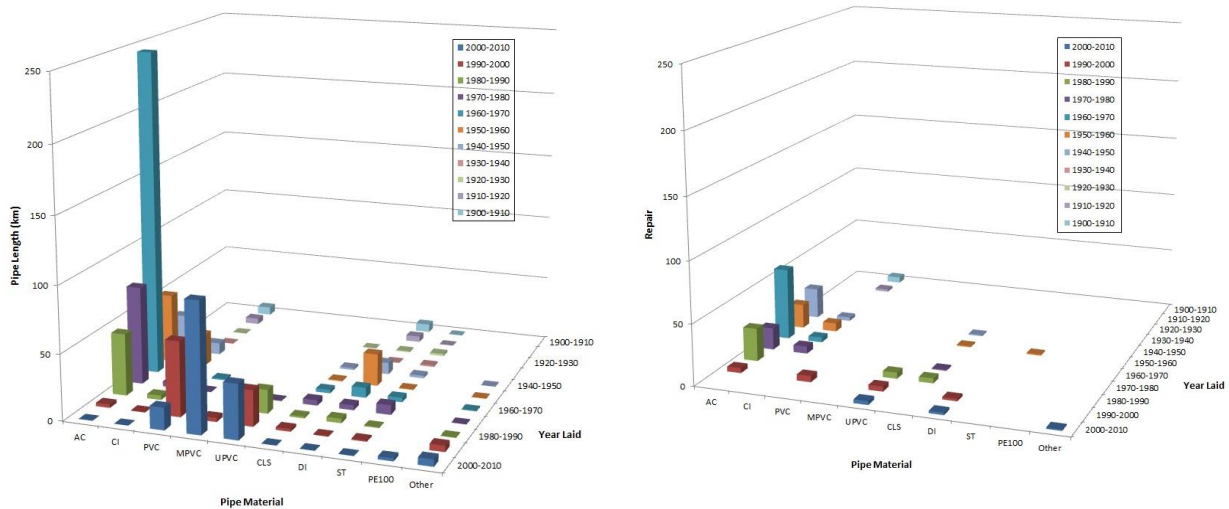
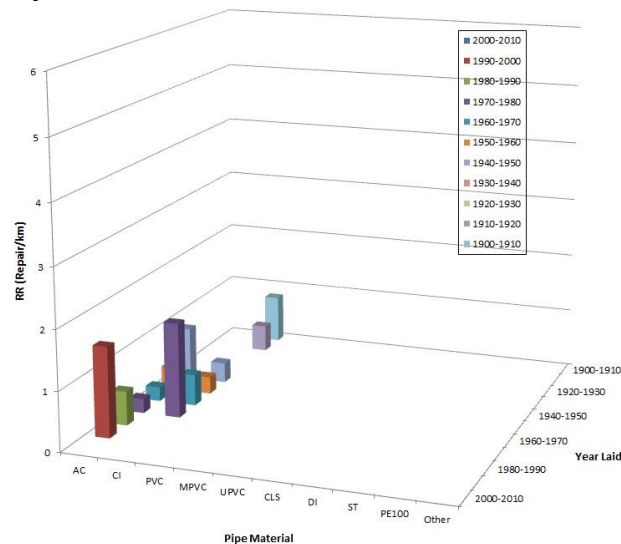
**Figure 5.** Pipelines in non-liquefaction zone with respect to pipe material and year of construction

Figures 5a, 5b, and 5c show, respectively the length in km, number of repairs and repair rate of pipelines in the non-liquefaction zone with respect to pipe material and year of construction. It should

be noted that Figure 5c shows the RR values only for the pipelines which pass the screening criteria explained above. Comparison of figures clearly shows that the repair rates are much higher in the liquefaction zone. Also AC pipelines performed worse compared to other pipelines. The spatial trends and pipe material effects in pipeline repairs can be analyzed by using clustering techniques. This method previously applied to City of Los Angeles water pipelines damaged by the 1994 Northridge earthquake [12]. An application of the k-means clustering analyses to Christchurch water pipeline damage data provided promising results [13]. Another method, fuzzy c-means clustering technique, is also one of the powerful methods which has been utilized in the analyses of pipeline damage in Christchurch (Figure 6).

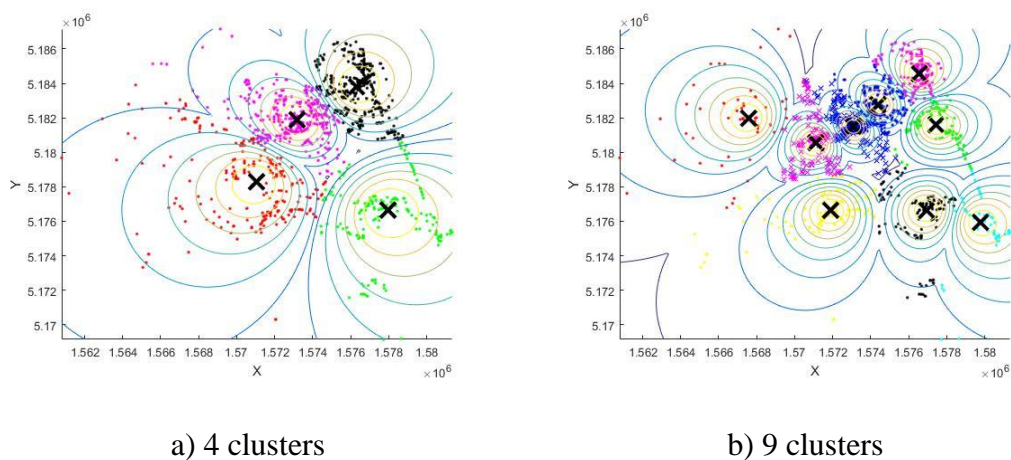
**Figure 6.** Fuzzy c-means clustering application to Christchurch pipe repairs.

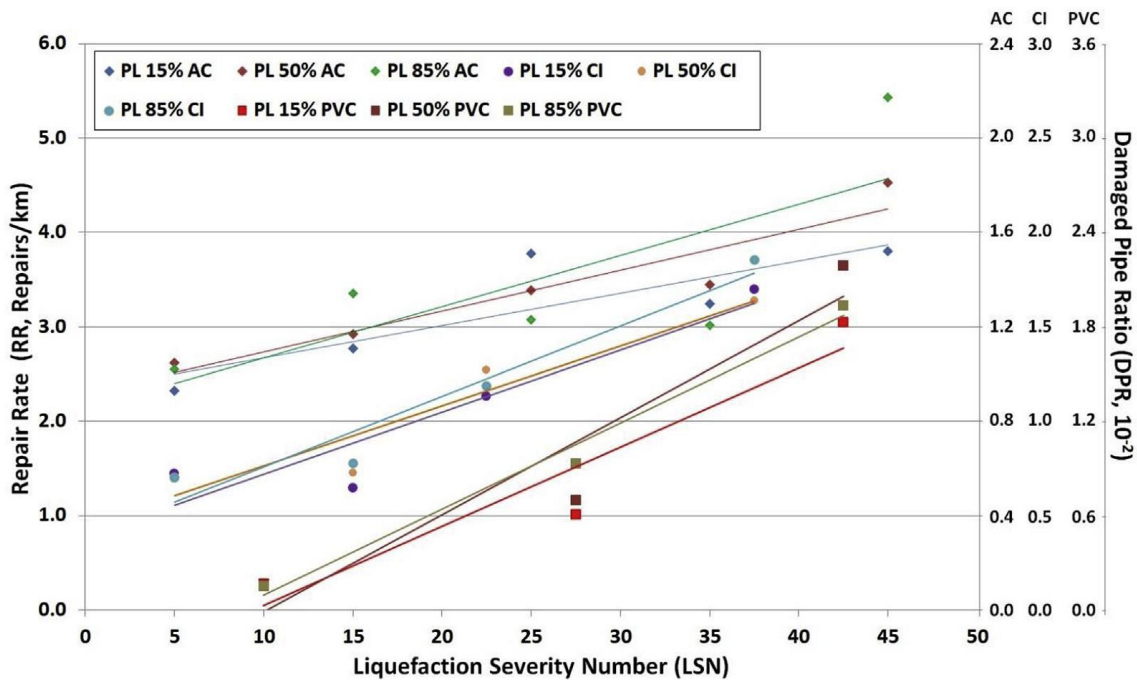
Although pipe material type and pipeline instalment year are important for the seismic performance of pipelines, they are not the only factors that control the pipe behavior. The magnitude and the extent of seismic loading can be critical as well. The level of shaking in non-liquefaction zones and the level of ground deformations in liquefaction zones can force the pipeline to failure. For example, O'Rourke [3] and Toprak [7] utilized lateral strains and ground deformation parameters when developing pipeline damage correlations in liquefaction zones and ground velocity parameter (GMPGV) when developing pipeline damage correlations in non-liquefaction zones. Toprak [4] proposed the first time the use of liquefaction severity parameters in pipeline damage correlations and provided respective relationships. Those relationships are expected to contribute to loss estimation studies for urban areas. Figure 7 shows such a relationship only for one of the liquefaction vulnerability parameters, liquefaction severity number (LSN).

**Figure 7.** RR and DPR vs. LSN relationships for AC, CI, and PVC pipelines and probabilities of liquefaction of 15%, 50%, and 85%. [4]
