Geotechnical site investigation and evaluation of 20 March 2019 Mw 5.5 Acıpayam (Denizli) earthquake

Halil KUMSAR^{1*}

Received/Geliş Tarihi: 05.07.2020
Accepted/Kabul Tarihi: 23.10.2020

doi: 10.5505/pajes.2020.72798
Special Issue Article/Özel Sayı Makalesi

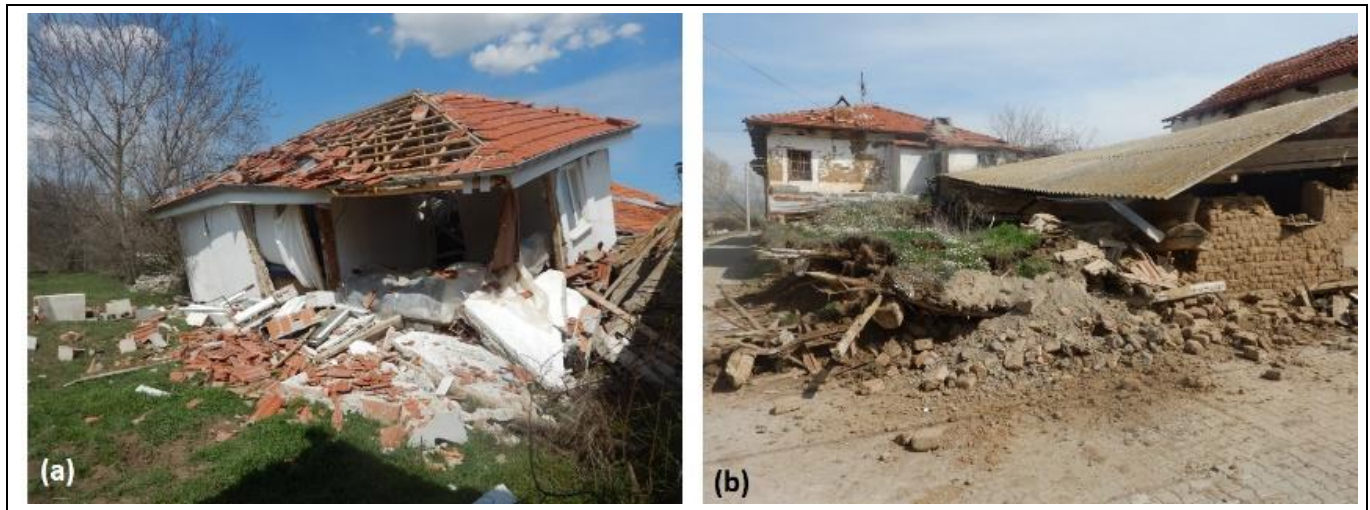
[33] equation gives lower A values than [32] and [34] equations (Table 2). Maximum A values of at KISK7, UCSK5 and OGSK1 locations are 3.68, 3.70 and 3.0 respectively and, they are in medium hazard level as given in Table 2 [38]. At these locations adobe, brick made masonry houses were heavily damaged due to earthquake. Reinforced structures were slightly damage and non-damaged (Figure 8a,b; Figure 9a,b; Figure 10a,b).

Figure 8(a): Heavily damaged hollow brick structure, (b): Collapsed adobe structure in Kirka village.

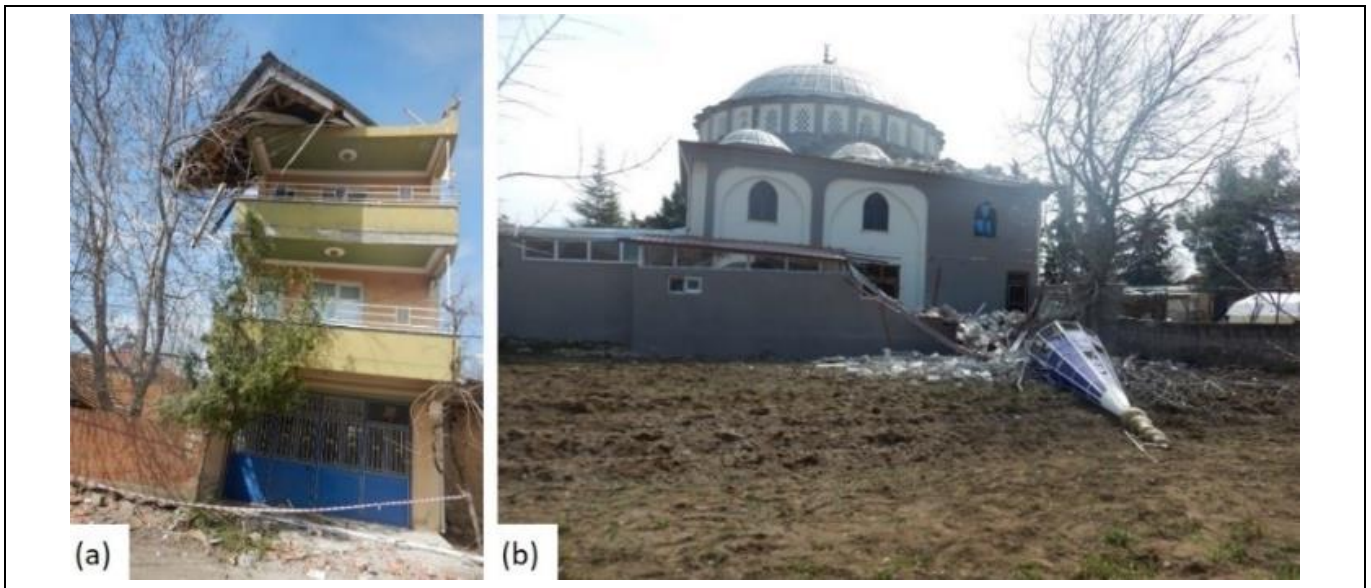
Figure 9(a): Hollow brick built roof floor failure of a reinforced structure. (b): heavily damaged masonry mosque in Oğuz village.

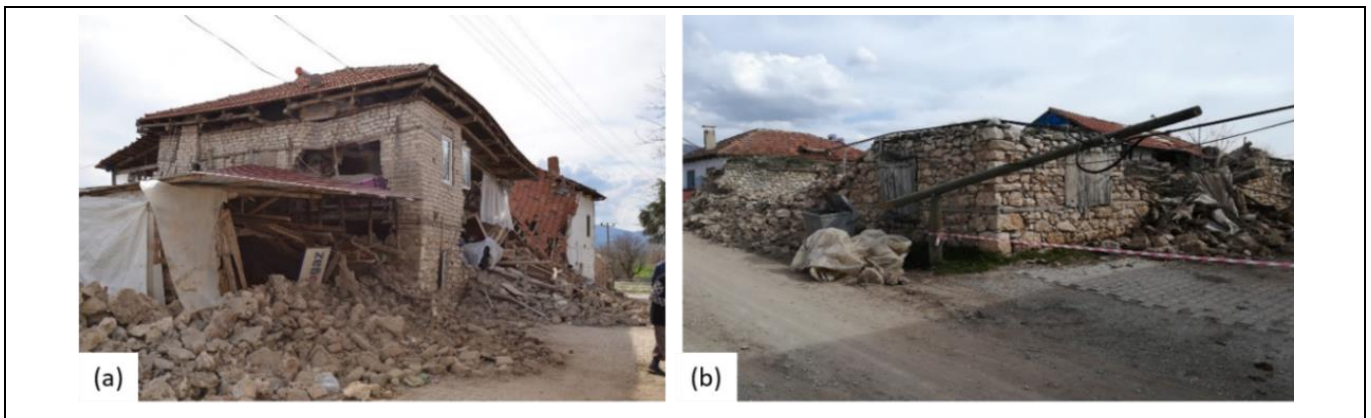
Figure 10(a): Collapsed adobe structure, (b): heavily damaged masonry structure and broken electric pole in Uçarı village.

Soil amplification factor of soils at UKSK1 location in Uçarı village is 1.79. At this location and in close area adobe, brick made masonry houses were heavily damaged and weak reinforced structures were moderately damaged. As the epicenter of the earthquake is 4 km close to Uçarı village, heavy damage on the masonry structures occurred during the earthquake.

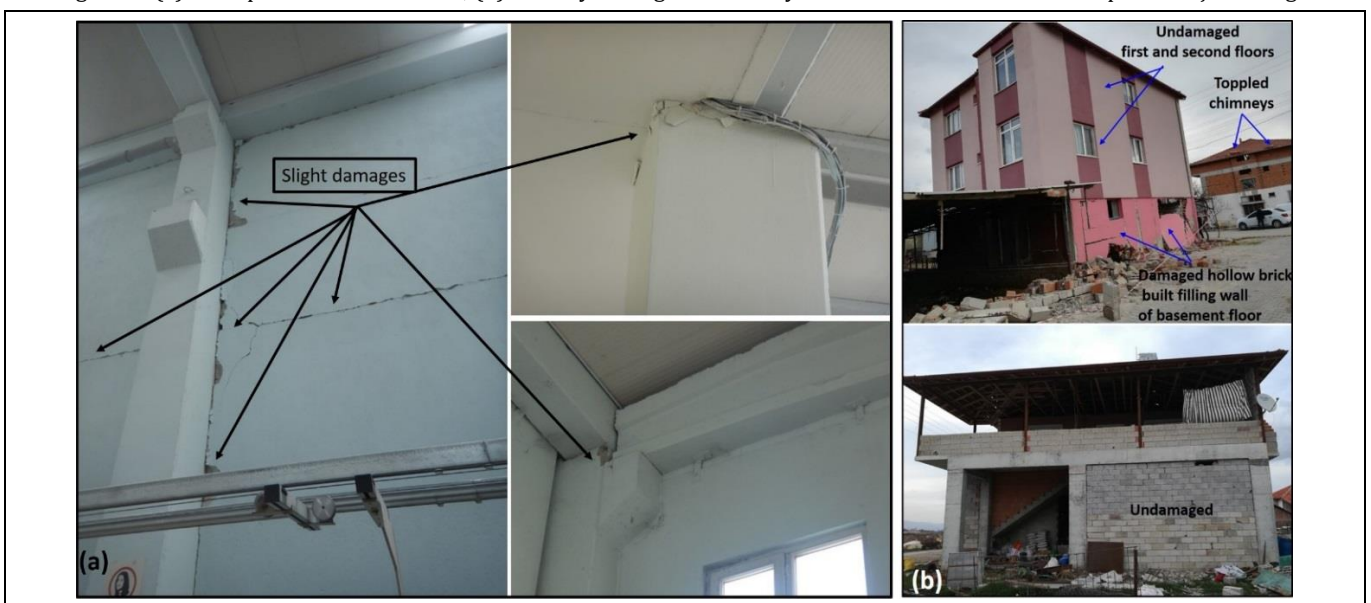
5.5 magnitude Acipayam earthquake caused slight damages on precast factory structures built on soft soils in the Acipayam basin. These damages are usually fissures and cracks at the connection parts of precast elements. Such as, beam and wall connections, beam and column connections, column and wall connections. There are also damages on suspended ceilings of the factory structures in the basin (Figure 11a). Single-storey reinforced structures, built on soft soil sediments in the basin, are usually undamaged (Figure 11b). However, multi-storey reinforced modern structures have damages on the hollow brick built walls in the basement floor (Figure 11b) masonry roof floor (Figure 8a). These reinforced structures had no damages on their beams and columns.

Figure 11(a): Damages on precast concrete modern textile factory structure in Yassihüyük village, (b): Partly damaged three-storey reinforced structure and undamaged single-storey reinforced structure in Apa village.
