Damages to unreinforced masonry buildings by the Van earthquakes of 23 October and 9 November 2011

Y. S. Tama¹, A. Solak², N. Çetinkaya¹, G. Şen³, S. Yılmaz⁴, and H. Kaplan¹

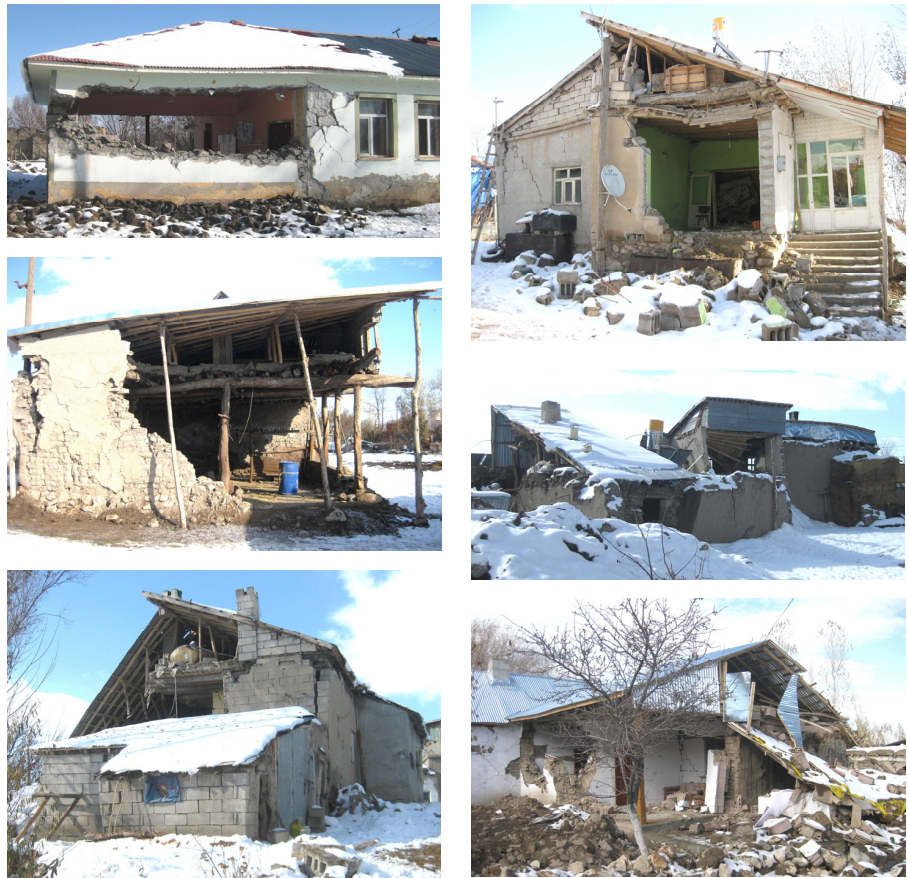
URM buildings are usually constructed from locally available construction materials in the countryside of Van Province. Masonry construction technique is similar in rural settlement areas at the disaster region. Most of the affected buildings were one-storey and had a heavy roofing of a thick composite slab made from mud and timber. This type of heavy roofing significantly increases the seismic base shear demand. Those non-engineered URM buildings were not earthquake resistant and were not in compliance with Turkish Seismic Codes (MPW, 1975; MPW, 1998; MPW, 2007). Various types of damages are exemplified in Fig. 5.

Fig. 5. Various types of damages observed at URM buildings after the 2011 Van earthquakes.

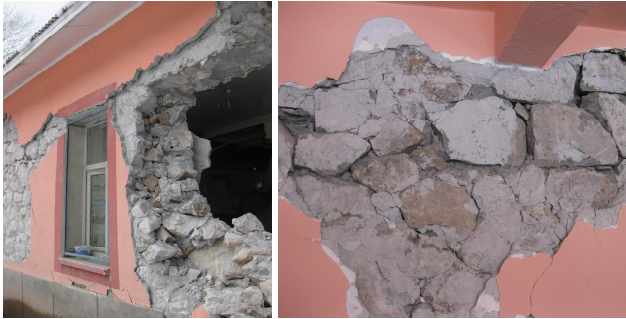
matic shapes, with parallel surfaces. In most of the investigated cases, stone blocks do not have a proper shape to be as a masonry wall material. Walls were usually formed by varying sizes of stone blocks. In the region, walls were composed of an inner and an outer wythe. However, configuration of those without interlocking elements causes both wythes to behave as independent walls, where the net length of the outer wythes of walls was considerably greater than the inner. Therefore, outer wythes become more prone to out-of-

plane failure. Typical examples of these types of damages are shown in Figs. 6 and 7.

Fig. 6. Profile of a poorly constructed damaged wall.

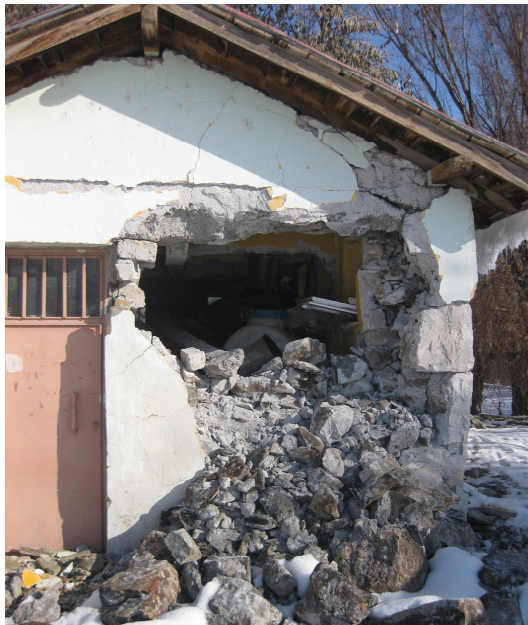
Fig. 7. Unconnected outer and inner wythes.

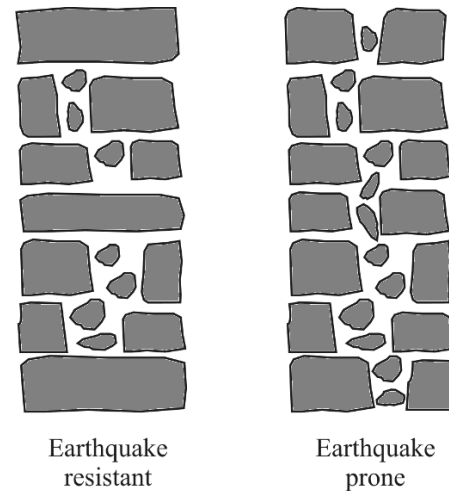
A typical wall cross section in rural areas of Van is compared with a typical seismic resistant section in Fig. 8. It clearly shows how the slenderness of wythes were increased due to lack of interlocking elements.

Fig. 8. Typical cross sections of earthquake resistant and fragile stone masonry walls.

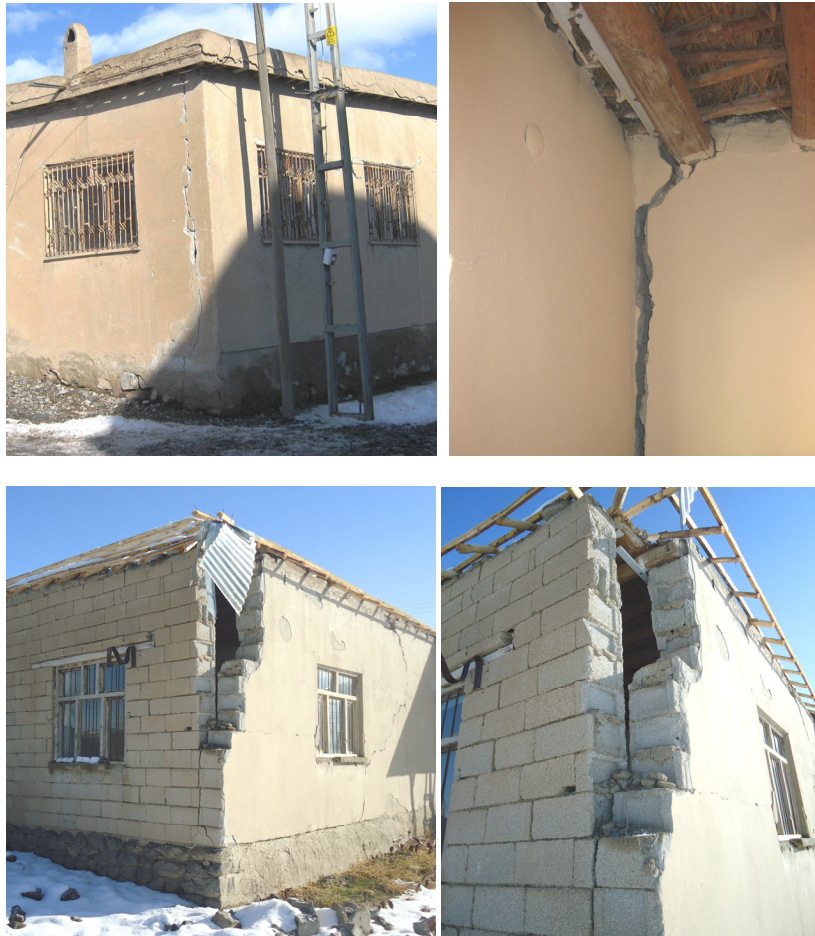
In a seismic-resistant masonry building, crossing walls have to be interlocked properly to improve out-of-plane strength. The problem of unconnected intersecting walls is very common in the region (Fig. 9). Due to bad connection detail of the intersections, safety of the connections relied on tensile strength of the mortar used for connection. Unconnected walls were more prone to out-of-plane failures (Kaplan, et al., 2008). These types of deficiencies were not limited to external wall-partition wall intersection. At the corners of the buildings, where two external wall intersects, masonry units were not overlapped sufficiently so as to ensure an earthquake-resistant connection (Fig. 9).

Figure 9 shows that walls having damaged corner connections are more open to out of plane failure.

Fig. 9. Damages observed at intersection of outer walls.

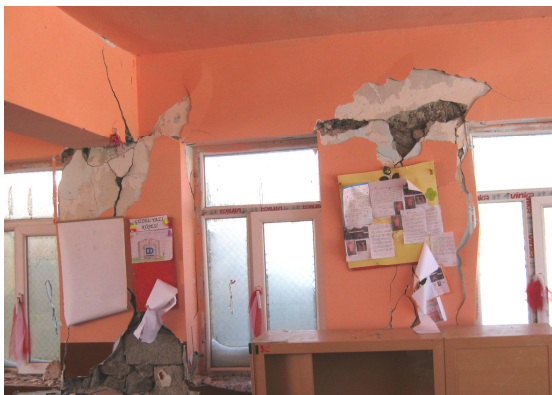
Two examples of damages due to wall openings are given in Figs. 10 and 11. The problem in the former is the short distance between two adjacent windows. In the latter figure the problem is the short distance between the opening and the building corner. Due to this wall formation, damage was concentrated around the opening.

Fig. 10. Damage between two wall openings.

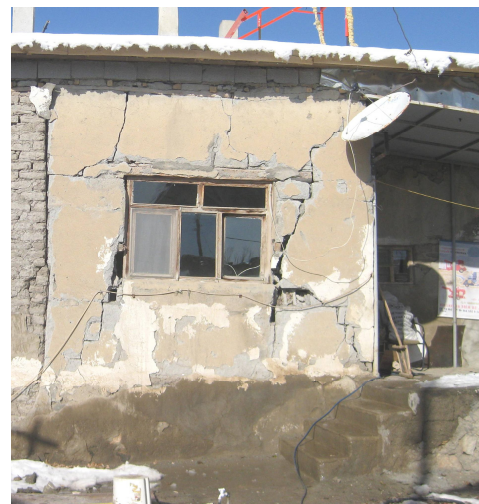
Fig. 11. Damage concentrated around wall opening near the building corner.

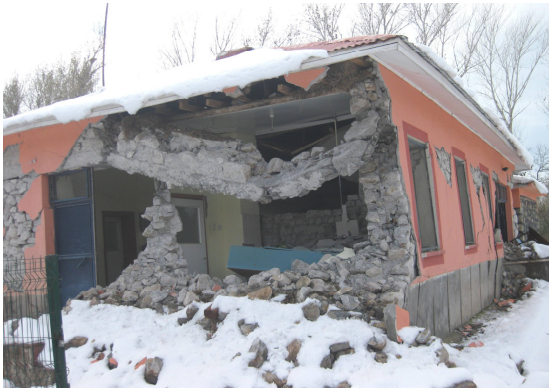
Out-of-plane failure is an important component of complex nonlinear masonry behavior. It may result from the combination of several deficiencies. Long, unsupported, slender walls and improper wall section formation (like unconnected inner and outer wythes) are some of those deficiencies. The lack of bonding beams at the top of the walls and light roofs with insufficient in-plane stiffness are also important reasons for this type of damage. In both cases, it is not possible to provide diaphragm effect at the roof level (Fig. 12).

Fig. 12. Out of plane failure.

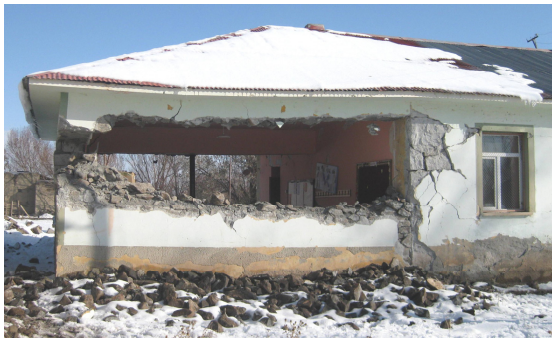
An example of out-of-plane failure due to unsupported wall length is given in Fig. 13. Unsupported wall length is beyond the code limits not only due to improper partition wall configuration but also to unconnected wythes. Net length of the slender outer wythe was significantly great and it failed. This phenomenon is explained in Sect. 4.1. Besides, insufficient connections of crossing walls can also lead to failure.

Fig. 13. Out-of-plane failure due to long unsupported wall length.

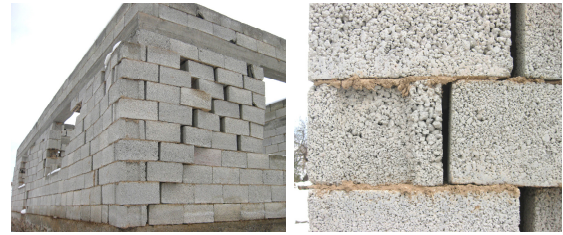
In a large portion of the investigated structures, mud was used as adhesive between wall bricks (Fig. 14) Using neither cement nor lime as adhesive decreased the cracking strength and base shear capacity of the wall. For these reasons, wall blocks were separated from each other under very small shear forces.

Fig. 14. Wall damage due to low strength joint adhesive.

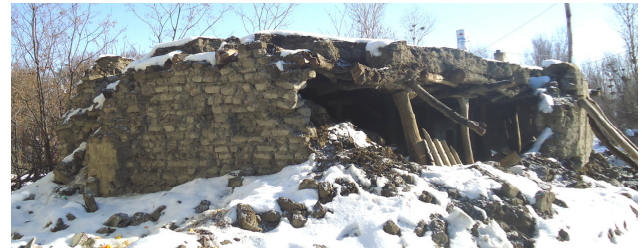
Apart from the reasons mentioned before, the base shear demand of the structure expected in the earthquake is related to the weight of the structure. In many damaged URM structures in the earthquake region, heavy soil roofing constructed for thermal and water insulation purposes were observed (Fig. 15). For this reason, the walls which had already low lateral strength due to non-engineered construction were subjected to larger shear forces.

Fig. 15. Heavy roofing with soil.
