EARLY BYZANTINE STRUCTURE AT GERENKUYU MEVKİİ OF YALI – BODRUM

ABSTRACT

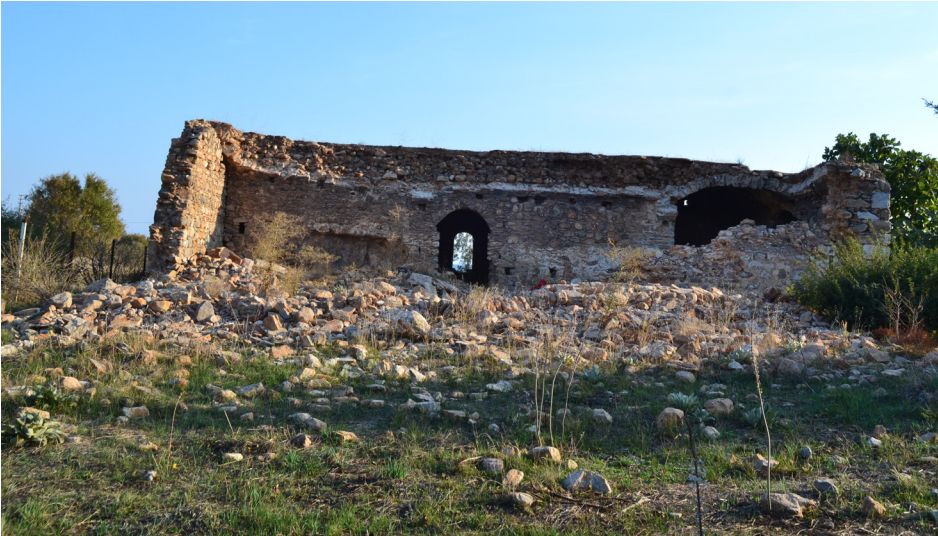
Fig. 2:
General view from
the north, before
cleaning work
(November 2018).

North Façade: Currently, the north façade is in ruins except for a small part in the west (Fig. 2). Originally it housed the only doorway leading into the interior of the building and there was a small loophole window in the eastern half (Fig. 3). The pieces of the doorway, fallen down in the earthquake together with the rest of the façade, were removed and placed aside in the course of cleaning work in early December 2018. The jambs, lintel and threshold are of limestone. The jambs consists of multiple pieces; the western jamb is in three pieces while the eastern jamb is in four pieces. In the middle of both jambs is a horizontal piece giving a decorative effect. The

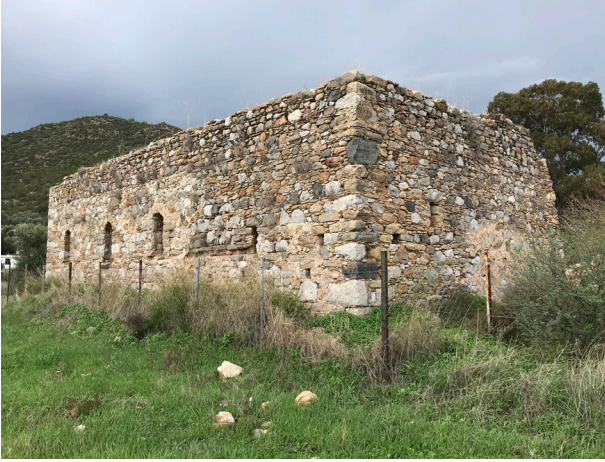
Fig. 4: General view of the east and south façades (2018).

East Façade: This blind façade has a loophole about 150 cm above the current ground level. The smaller square hole further down is not a window but rather one of the several holes where beams should have been placed. About the middle are traces of plaster (Fig. 4).

South Façade: Accentuated with three windows in its western half, the south façade also has a loophole window and two holes for beams in its eastern half. Along the entire façade, a ledge of 10 cm height and 6 cm depth extends at the level of the window sills and it was later filled with small stones, few pieces of bricks and lime mortar with brick powder (Fig. 4).

The only relieving beam attested is along the entire south façade at the level of the window sills, extending further about 1 m on the west façade. The place of the beam was later filled with a lime mortar containing brick fragments and powder (Fig. 4).

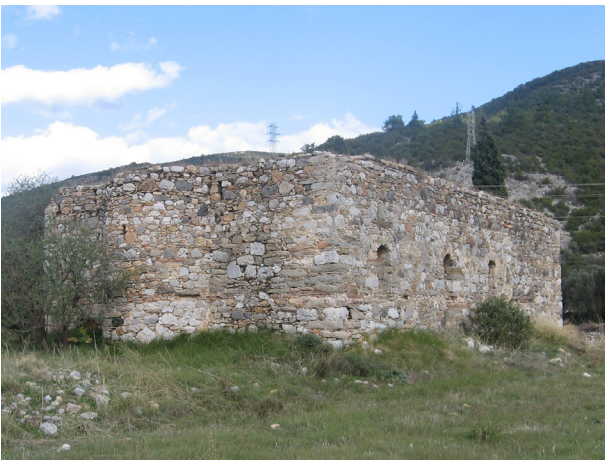
Fig. 5: West façade (2010).

West Façade: This façade has an apse-like protrusion in the middle. In the middle of the upper part of this protrusion is a loophole window and on the top levels of the straight wall sections is another loophole window on either side. In addition, a hole for a beam is noted by the north edge, about mid-height (Fig. 5). However, a fig tree grown in the recent years conceals the protrusion from sight and has reached the level of a threat for the building. A section of 50-60 cm in height, running along the top of all the façades seems to have been a later construction, which may indicate a repair. This level corresponds to the vaults inside (Figs. 4, 5).

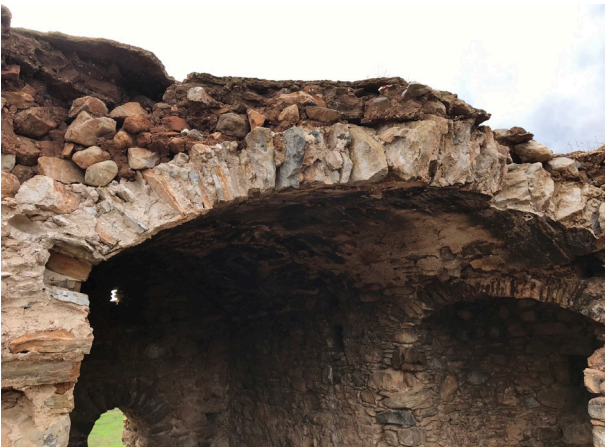
Fig. 6: Detail of the west vault and the mud-stone filling and 'concrete'-like flat roofing (2018).

Superstructure: The structure is covered with a flat roof on the exterior. The barrel vaults of stone and lime mortar inside are covered and levelled with a mixture of mud mortar probably containing local *geren* clay and stones and coated with a "concrete" layer (Başak and Bektaş, 1983: 121) (Fig. 6).

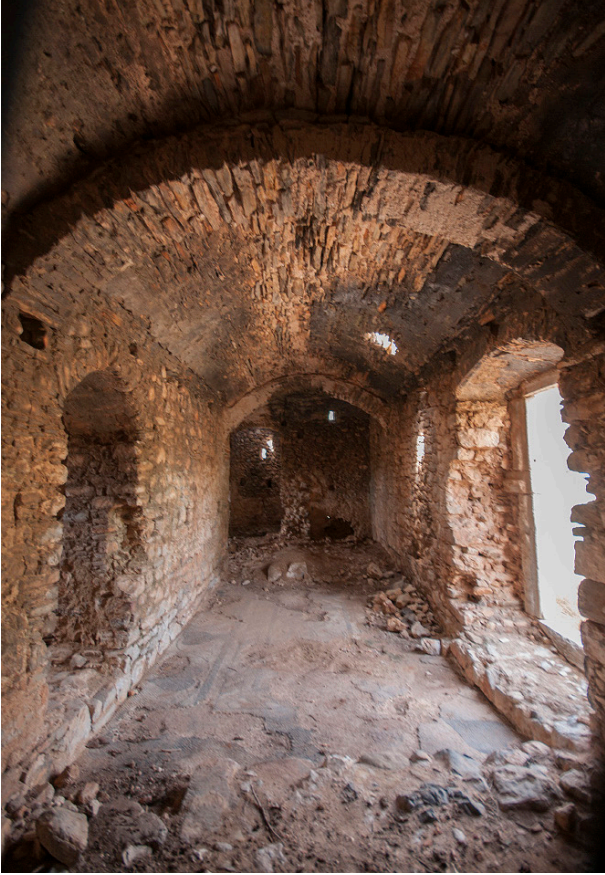
Fig. 7: General view of the north wing, looking west (2010).

covered with a barrel vault in the east-west direction (Fig. 7), the entire vault of the north wing and a large part of its exterior wall fell in the earthquake of July 2017 (Fig. 2). Therefore, the northern half of the building was buried under debris until the cleaning work in early December 2018. As it is known from previous accounts and photographic documentation, the floor of U01 is paved with polychrome mosaics, which will be presented below (Fig. 8).

At the springing level of the barrel vault, now fallen, is a series of square holes for tie-beams. The existence of two supporting arches for the vault is known from previous photographs; one between U01 and U02 and the other between U01 and the west wing (Fig. 7).

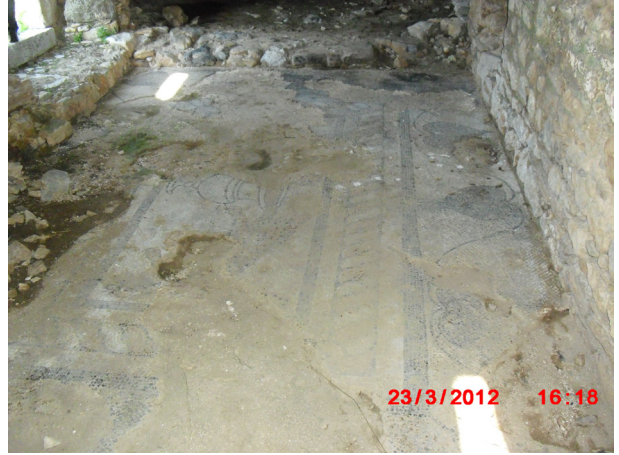
Fig. 8: Mosaic pavement in U01 (2012).

Mosaic Flooring in U01: The mosaic flooring at U01 was previously covered with geotextile and sand by the Bodrum Museum of Underwater Archaeology; therefore, the author has not been able to see it. However, the following can be reported from previous publications and old photographs (Fig. 8):

The polychrome mosaic pavement fills the entire U01 measuring about 478 x 300 cm and its borders follow the walls of the unit, thus clearly indicating that it was made for this unit; that is, it does not belong to any earlier or other structure. The outermost wide border features a scroll of large ivy leaves. Five ivy leaves on the long sides and four on the short sides are placed in alternating direction. Then comes a set of two narrow bands flanking a wider band of guilloche. The central panel is contoured with a thin border and features a figural composition. In the centre of the panel is a large crater upon which two speckled leopards jump. The tails of the leopards curve up filling the southeast and southwest corners of the panel.

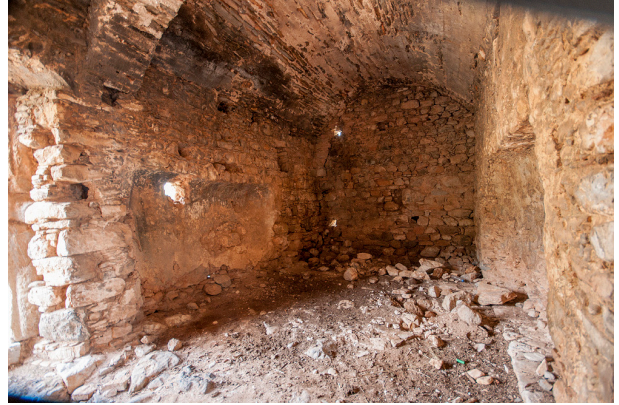
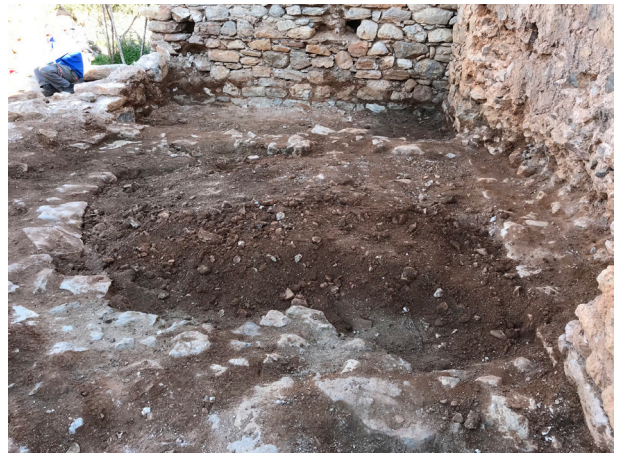
Fig. 9: Units 02 and 02A a: in 2010; b: after cleaning work in December 2018.

Unit 02 to the east of U01 was originally accessed via a doorway at the southern end of the wall separating the two units (Figs. 7, 9a-b). The northern and southern walls of the unit were accentuated with a large but shallow niche (W. 270 x H. 150 cm); the extant southern niche bears traces of painted plaster but it is not possible for the time being to state whether these traces actually belonged to a fresco or not (Fig. 9b). The wall separating U02 from U03 was originally pierced by a round-arched doorway at its eastern end but it was later blocked with similar

The cleaning work carried out in early December 2018 revealed traces of the floorings of the units, except U01. As a result of the cleaning work, Unit 02A became discernible and a stone blockage with mud mortar was uncovered before the non-extant northern niche and the entranceway to U02. This pavement is not attested in U02A. Between units U02 and U02A the foundation of a wall was uncovered but nothing indicating a doorway could be attested (Fig. 9b).

Holes for tie beams and holes for wall beams: At the springing level of the vaults in all three wings is a series of square holes for placing tie beams, which originally improved the strength of the vaults (Figs. 9a, 10, 18, 11).

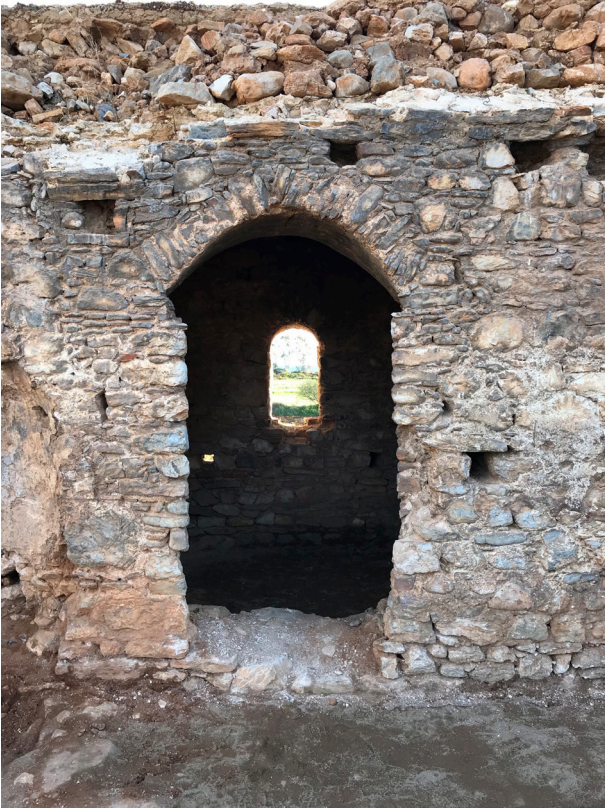
Fig. 10: Doorway leading into U04, showing springing of the supporting arch and holes for tie beams (2018).

A doorway right opposite the main doorway leads from U01 into U04 in the south wing. The round arch of this doorway looks somewhat pointed at top suggesting a somewhat amateurish workmanship. This doorway flares out into U04 (Fig. 10).

In the walls, there are square holes cutting across the thickness of the walls and their positions from the ground level vary in height. These holes do not exhibit a pattern of placement except the fact that they are mostly either in the middle or lower parts of the walls. It is plausible that wooden beams were placed in them, possibly for improving the strength of walls (Figs. 10, 11, 17, 18).

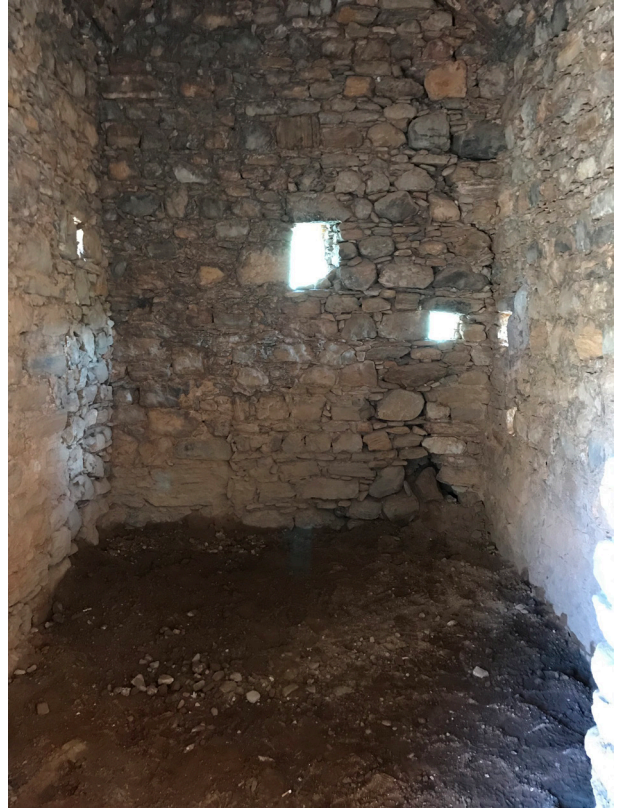
Fig. 11: Unit 03, looking east (2018).

The easternmost U03 is arranged almost like an *iwān* opening onto U04 via two protrusions. At the eastern end of its north wall is a doorway, later blocked, originally opening into U02A; at the centre of its east wall is a loophole window; at the western end of its south wall is another loophole window. Each of these walls also have a hole for a wall-beam (Fig. 11).

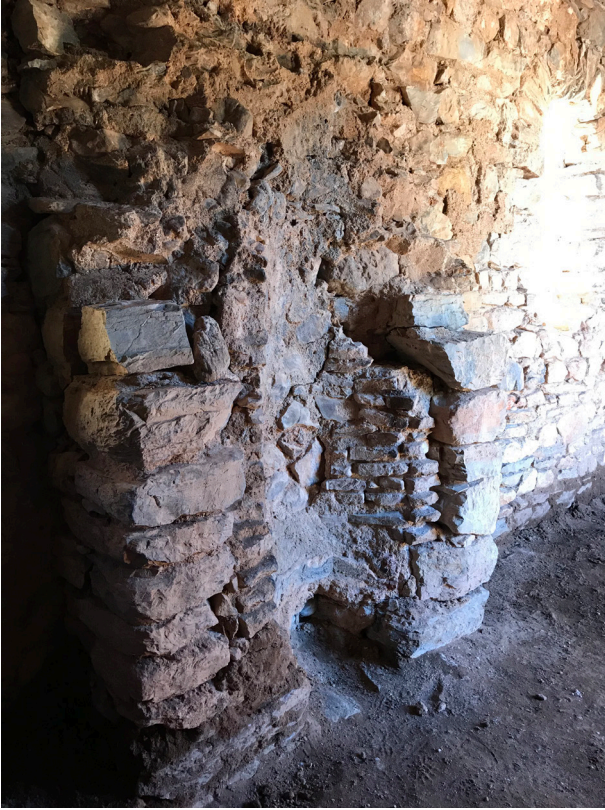
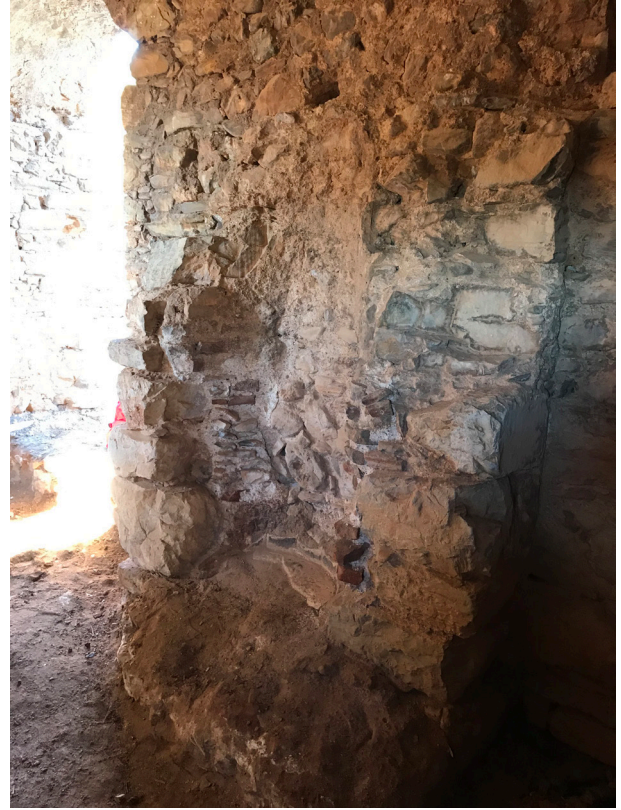
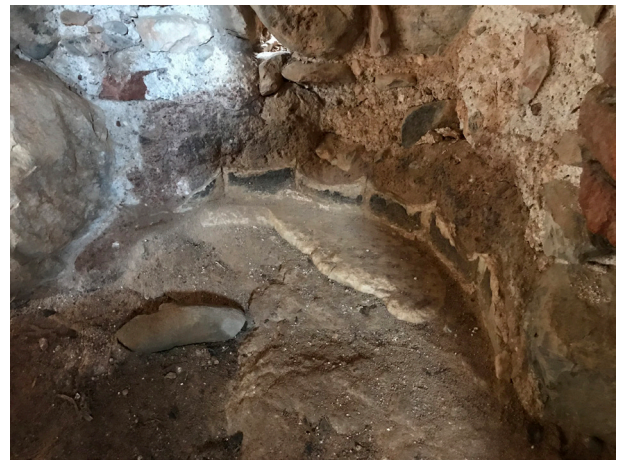
Fig. 12:
After cleaning work (December 2018) –
a: Southern protrusion niche;
b: Northern protrusion niche;
c: Detail of revetment in the northern
protrusion niche.

Protrusions from the north and south walls: Units 03 and 04 are thought to have the same floor level (Figs. 12a-b-c). The protrusions separating them from each other were built with two piles of coarsely dressed blocks bounding the niche recess and smaller stones with mortar in between, creating

the semi-circular niche. Although they seem to be added later on, a close examination indicates that the walls were slightly caved to place the blocks and there is no plaster layer between the niches and the body walls (Fig. 13). The interiors of the niches were probably faced with marble plaques in seven or nine facets; however, currently, the “marble” plaques are covered with a layer of petrified black substance (Fig. 12c). The floor level of the north niche is clearly attested from the platform surviving but the south niche’s floor has been lost. Another interesting feature of these protrusions is their height reaching 200-220 cm from the current walking level as inferred from the traces on the walls. They were also surmounted with an arch. No traces of any water supply or chimney are attested to ascribe any function to them.

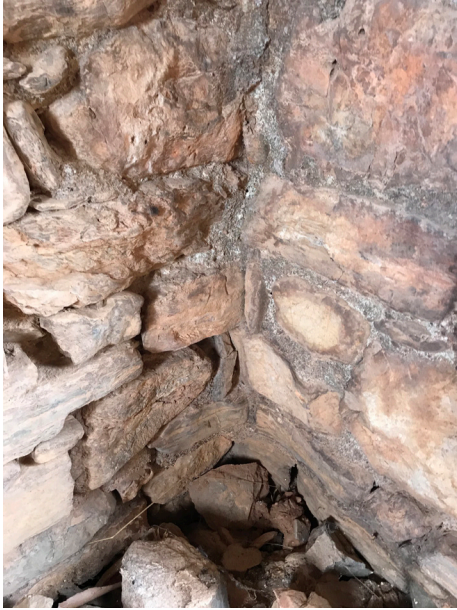
Fig. 13: Joining of the partitioning walls (2018).

Partition walls rising only 2 m: The walls separating U04 from U05 and U06 from U07 seem to have been only to a height of about 2 m as inferred from the traces on the body walls and previous photographs. At first glance, they seem to be built adjoining the body walls at a later date but a closer examination shows that they actually belong to the original construction phase because they do join into the body walls without any plaster layer in between. It is clear that these partition walls were not meant to carry any load and as far as it could be observed during the cleaning work, they do rise on foundations. The joining method of the partition walls is also attested for the joining of the protrusion niches between U03 and U04 (Fig. 13).

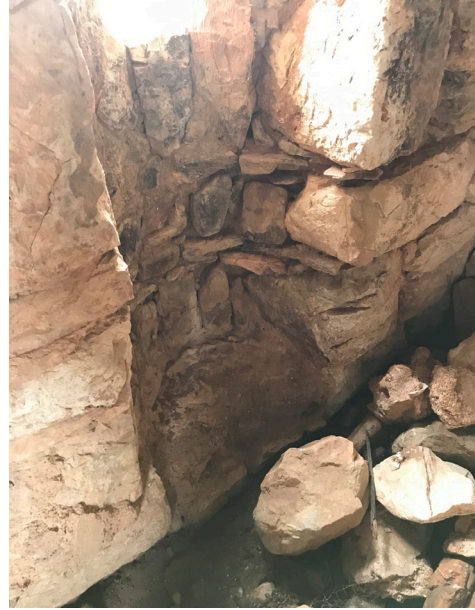
Fig. 15: Niche-window arrangement in the south wall of U05 (2018).

Unit 05 has interesting features. On its north wall is a shallow rectangular niche topped with a round arch. However, the window opening outside in its south wall is arranged as a semi-circular niche on the wall (Fig. 15) and the intrados of the window arch bears traces of a fresco (Collins and Záh 2006: 295). The floor level of U05 is clearly lower than that

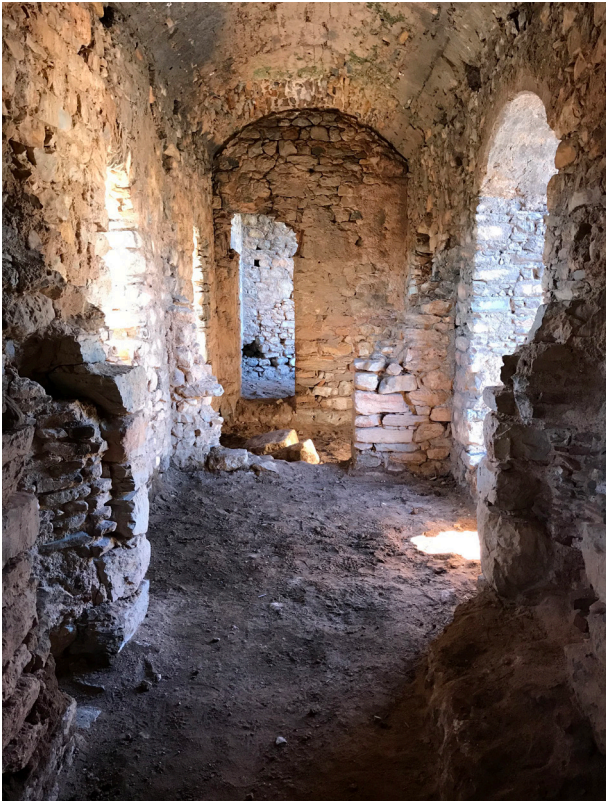
Fig. 14: General view of the south wing looking west: protrusion niches in the front, U04, partitioning walls, U05, doorway opening into U06; after cleaning work (December 2018).

Unit 04 in the middle of the south wing has a window opening out on its south wall. No traces of any flooring have been attested (Fig. 14).

The walls separating U04 from U05 rise about 2 m with a doorway left in between. These walls were not meant to carry any load and their connection to the main body walls is similar to that of the protrusions with niches separating U03 from U04 (Fig. 14).

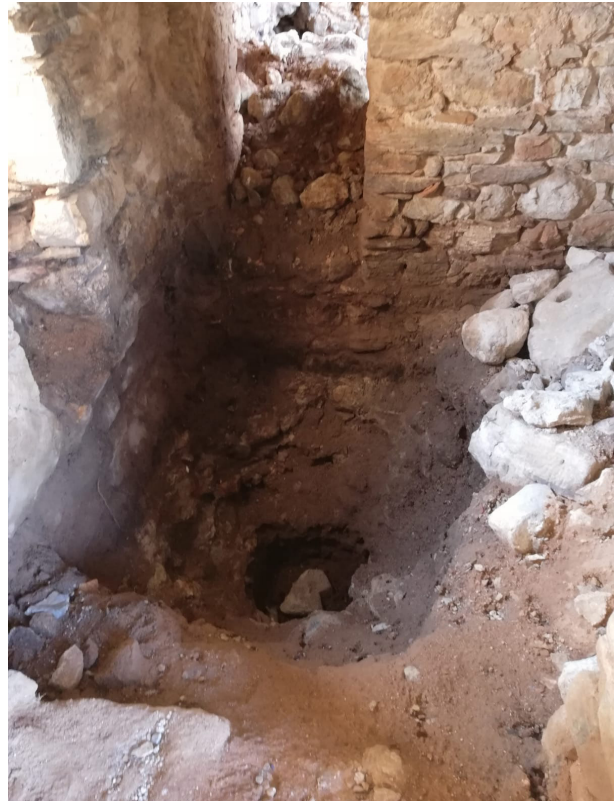
Fig. 16: The “well” dug in U05 by illicit diggers in February 2019.

of U04. The bottom level of the window's niche is also higher than the current floor level of the room. The two blocks with a hole in them should have been brought there from elsewhere much later. In February 2019, the building was damaged by illicit diggers once again and in U05, a pit like a well with a diameter of about 1 m and depth of 2 m was dug in the floor before the window; this "well" cut through a blockage of rubble and lime mortar; there was no indication for any hypocaust or other installation under the floor (Fig. 16).

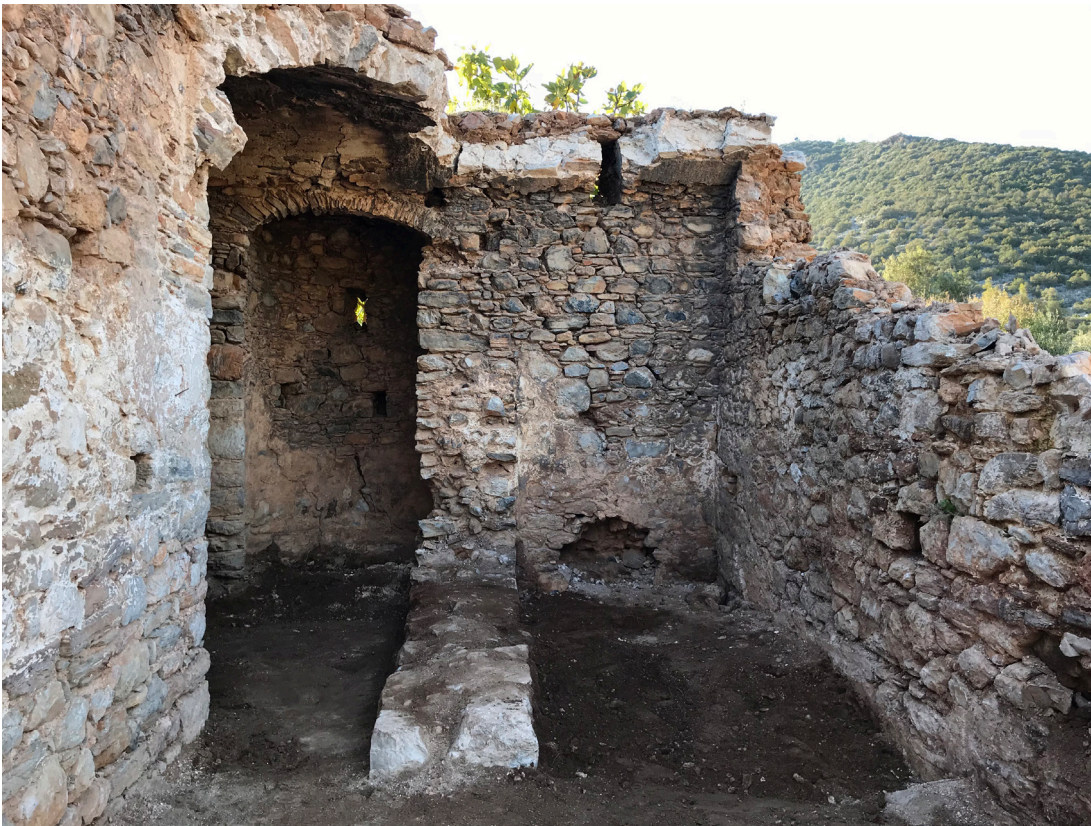
Fig. 17: View of the apse-like protrusion and U07, after cleaning work (December 2018).

divided into two by a stone wall rising about 2 m (Fig. 7), which collapsed in the earthquake as well (Fig. 17).

The wall that used to separate U06 from U07 is now preserved at the foundation level and during the cleaning work it became clear that it was rendered with a plaster with brick powder about 5-6 cm in thickness on its both faces (Fig. 17). Cleaning work at unit U07 brought to light no flooring but three layers of plaster on the walls.

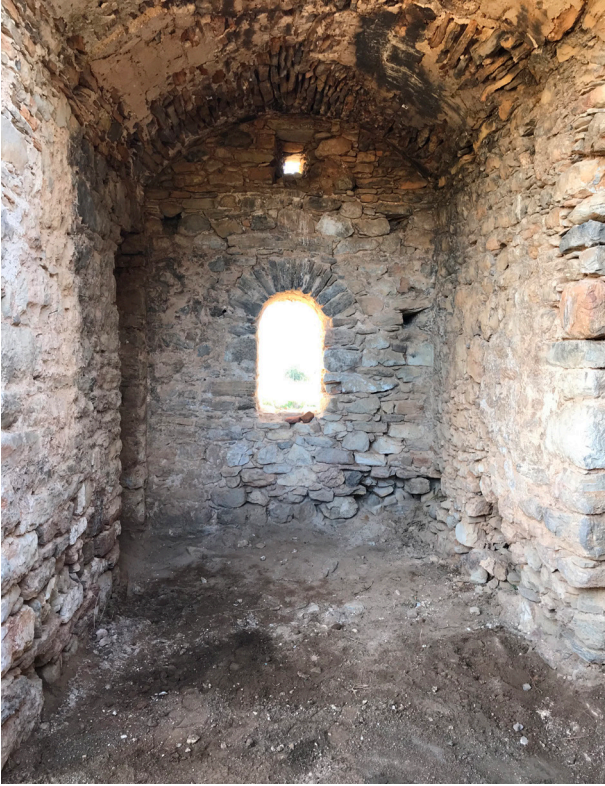
Fig. 18: Unit 06, looking south, after cleaning work (December 2018).

Unit 06 opens out with a round-arched window in the south wall and a wall-beam hole over it. The doorway at the south end of its east wall leads into U05. On its west wall is an apse-like protrusion, slightly bigger than a semicircle, protruding out (Fig. 18). Cleaning work brought to light a flooring of mortar with dense brick powder (*horasan*).

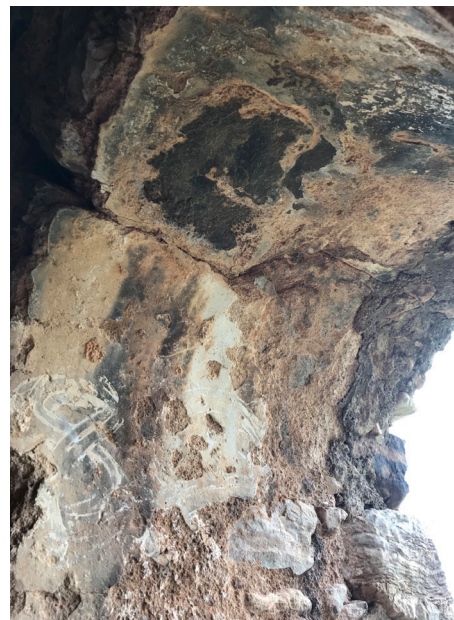
Fig. 19: Fresco traces in the intrados of window of U05 (2018).

Fresco Remains in U05: The window in the south wall of U05 is arranged into a semi-circular niche in the wall; its intrados was originally painted with a figural fresco, which is in a very poor condition today (Fig. 19). However, Collins and Záh (2006:

295) state that a soldier's head with a helmet of Late Antiquity is depicted there and give for comparison a follis coin depicting Justinian I (r. 527-565 CE) wearing such a helmet.

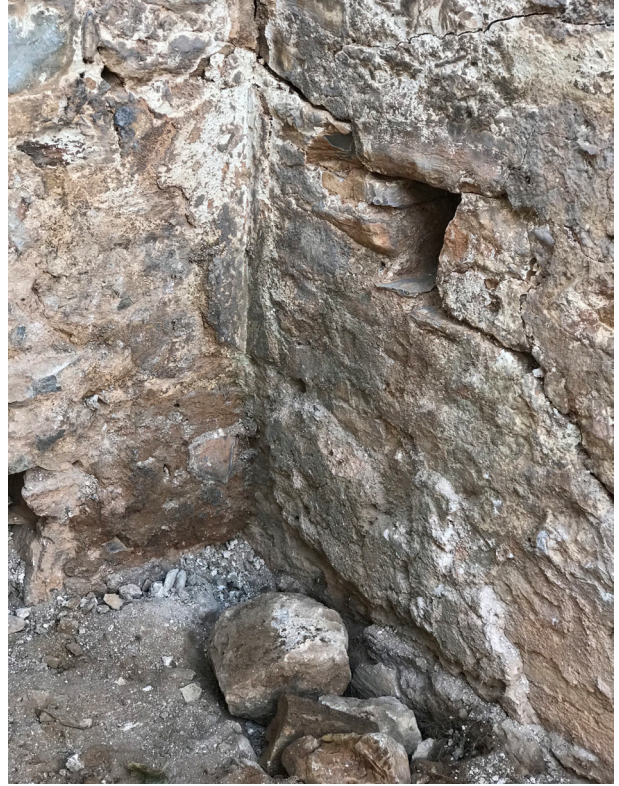
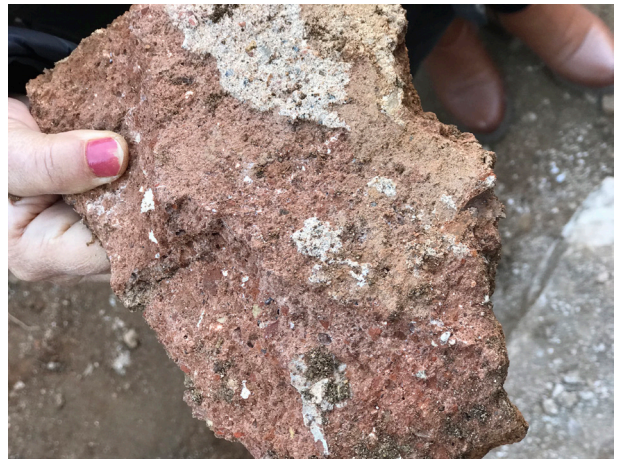
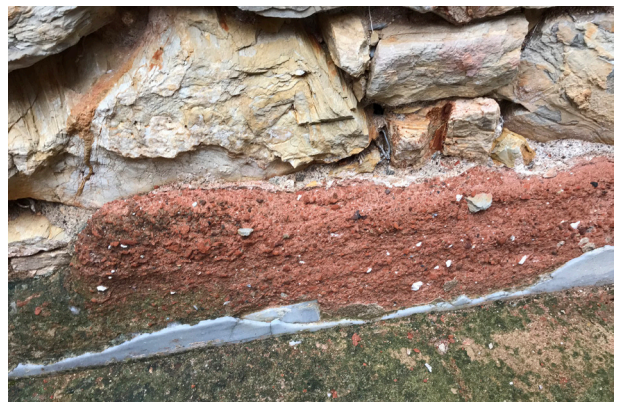
Fig. 20:
After cleaning work (December 2018) –
a: Northwest corner of U07, layers of plaster;
b: Thick plasters with high content of brick
powder from the west wing; c: used as bedding
for marble facing at the Early Byzantine
monastery complex in Torba (2018).

the exterior, the plastering did not cover the entire surface of especially larger stones. On the interior, particularly in the U01, U02 and U07, there is a very thin layer of plaster, which is not concealing the texture of the masonry. At the southwest and northwest corners of U07 three different layers of plaster were attested. The bottom one is a thin layer; the middle one is about 3-4 m in thickness and the top layer with high brick powder content is 6 cm thick, similar to that seen in U06 (Fig. 20a). The Early Byzantine monastery complex at Torba has a similar plaster with high brick powder content (Figs. 20b-c) used as bedding for marble facing. However, under present circumstances there is no evidence attested for similar marble facing at Gerenkuyu.
