## Pipe type and seismic performance in Christchurch, New Zealand

To cite this article: S Toprak *et al* 2020 *IOP Conf. Ser.: Mater. Sci. Eng.* **800** 012042

# Pipe type and seismic performance in Christchurch, New Zealand

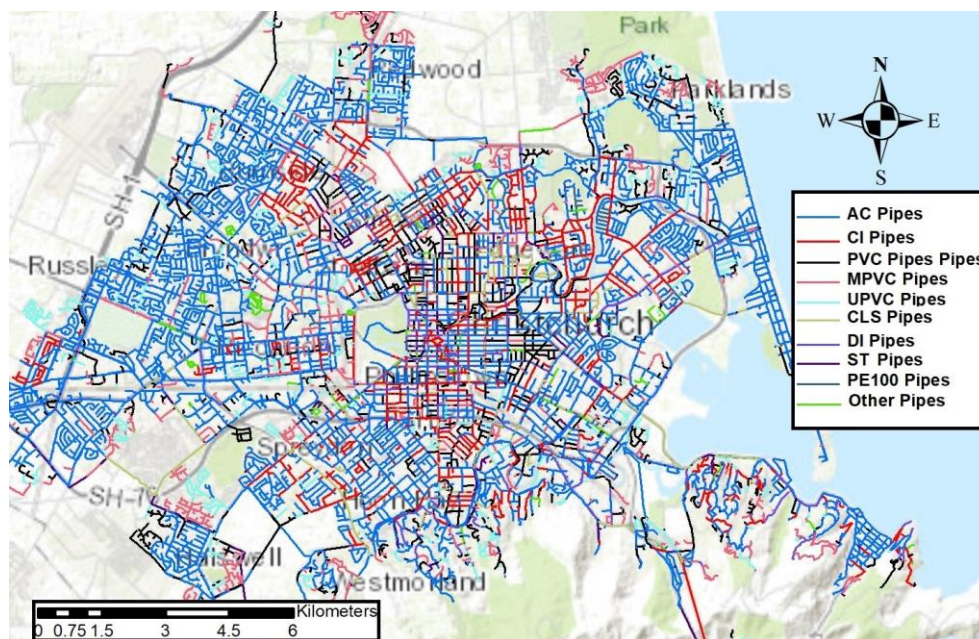
**Figure 1.** Pipelines in Christchurch with respect to pipe material

The water distribution system consists of various pipe materials. Figure 1 shows geographical distribution of Christchurch water main lines with respect to pipe material by the time the 22 February 2011 earthquake took place. Almost half of the pipelines are asbestos cement (AC) pipelines. Other major pipe types are cast iron (CI), polyvinyl chloride (PVC), modified polyvinyl chloride (MPVC), and unplasticised polyvinyl chloride (UPVC). About 9 % of the pipelines are concrete lined steel (CLS), ductile iron, concrete lined ductile iron (CLDI), steel (ST), and polyethylene 100. Less than one percent of the pipelines consists of polyethylene (PE), medium density polyethylene 80

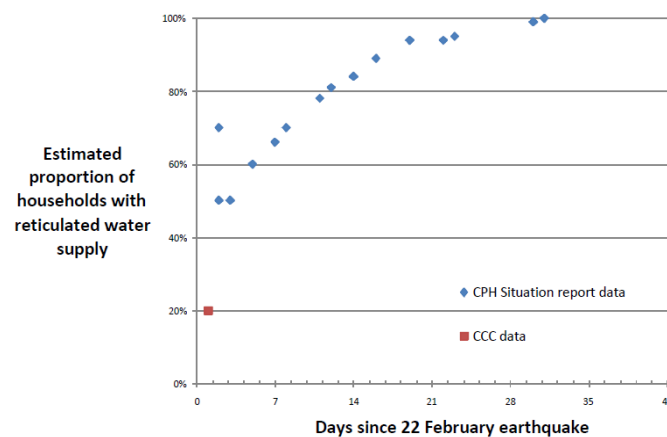
**Figure 3.** Water service recovery after the 22 February 2011 earthquake. [11]

The 22 February 2011 earthquake caused substantial damage to the pipelines (Figure 2). The total number of repairs to main pipelines was 1502. About two thirds of the damages occurred on AC pipelines. As shown in Figure 3, although service was provided to about half of the households a few days after the earthquake, the recovery took significant time. The City applied “boil water notice” to whole Christchurch between February 23<sup>rd</sup> and April 8<sup>th</sup>, 2011 to protect residents against disease. The “boil water notice” is about to treat tap or tanker water by boiling before any use for drinking, brushing teeth or preparing food.
