Geotechnical site investigation and evaluation of 20 March 2019 Mw 5.5 Acıpayam (Denizli) earthquake

Halil KUMSAR^{1*}

Received/Geliş Tarihi: 05.07.2020
Accepted/Kabul Tarihi: 23.10.2020

doi: 10.5505/pajes.2020.72798
Special Issue Article/Özel Sayı Makalesi

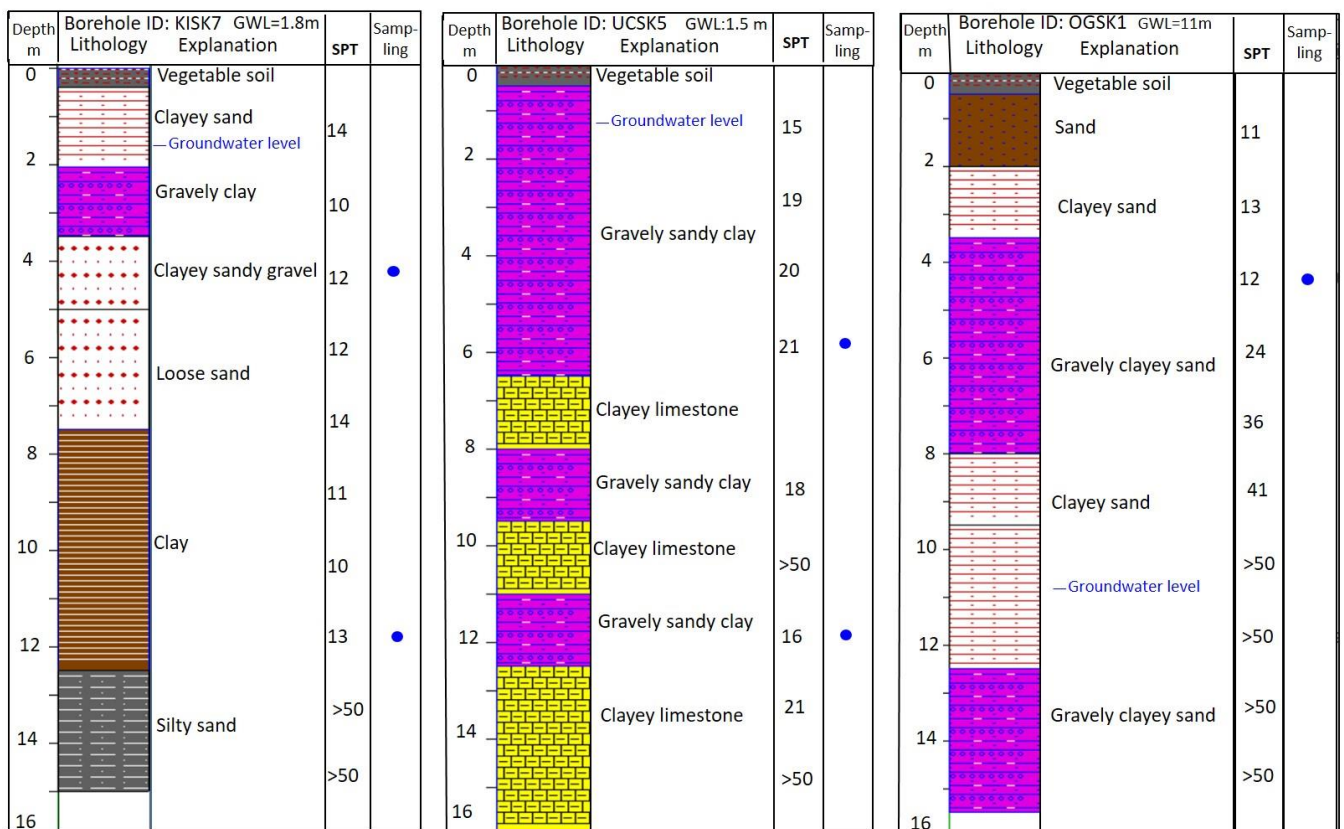
Figure 4. Geotechnical logs of the boreholes numbered as KISK7, OGSK1 and UCK5 in the Acipayam Basin.

KISK7 geotechnical borehole was drilled in the Kırca village having 15m depth [29]. Groundwater level in the borehole is 1.8 m deep from ground surface. Soil profile of the borehole made up of soft sediments in the first 12.5 m from the ground surface. Standart penetration test (SPT) values at this depth change from 10 to 14. Grain size distribution curves of soil samples are given in Figure 7. Soil sample of 4m depth consists of 13.33% gravel, 70.28% sand and 13.33% silt and clay. Soil type of the sample according to Unified Soil Classification System [37] is SW (well graded sands and gravely sands). This soil is

liquefiable soil but in the field liquefaction was not observed in this location after M=5.5 earthquake on 19 March 2019. Soil sample of 12 m depth contains 0.75% gravel, 28.9% sand and 70.35% silt and clay. Soil type of the sample in Unified Soil Classification System [37] is CL (inorganic clays of low to medium plasticity, gravely, sandy and silty clays).

According to the bounds for liquefiable soils [35] and 70.35% of silt and clay content, this soil is not liquefiable (Figure 4).

OGSK1 geotechnical borehole was drilled in Oğuz village and it has 15.5m depth [28]. Groundwater level in the borehole is 1.1m deep from ground surface. Soil profile of the borehole from ground surface to the bottom contains 0.4m of vegetable soil, 1.6m tick sand, 4.5m gravely clayey sand, 4.5m clayey sand and 3m gravely clayey sand (Figure 4).

SPT values from 1.5 m to 6 m varies from 11 to 24. The soil profile after 6 m gets stiffer with increasing SPT values from 36 to over 50. Grain size distribution curves of soil samples are given in Figure 4. Soil sample of 4.5 m depth consists of 21.58% gravel, 33.06% sand and 43.36% silt and clay. Soil type of the sample in Unified Soil Classification System [37] is SC (clayey sands, sand clay mixture). This soil is not liquefiable [35] (Figure 7).

Soil profile of the borehole from ground surface to the bottom contains 0.4 m vegetable soil and succession of gravely sandy clay and clayey limestone. Gravely sandy clay layers have STP vales between 15 and 21 while clayey limestone levels have SPT values bigger than 50 (Figure 4). Soil samples of 6 m and 12 m depths contain 82.44% and 76.04% silt and clay respectively. Soil type of the both samples in Unified Soil Classification System [37] are CL. Soils in both levels are not liquefiable [35] (Figure 7).

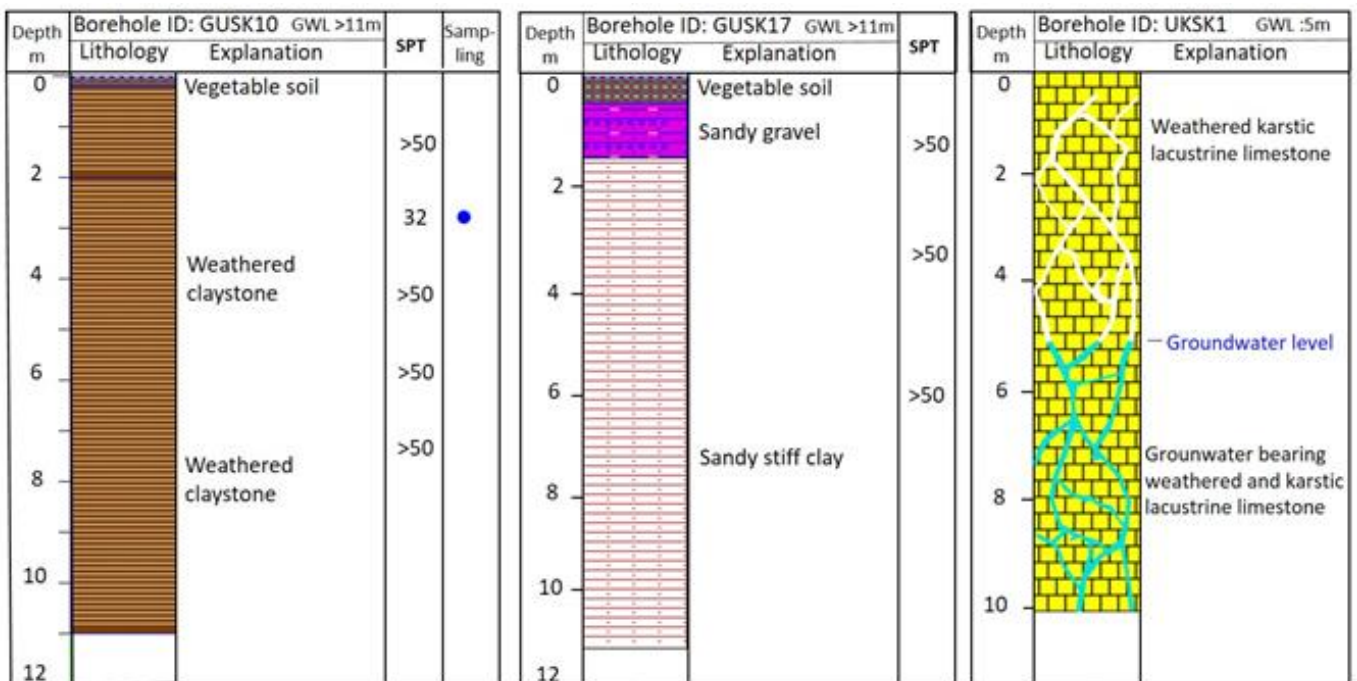
Figure 5. Geotechnical logs of the boreholes numbered as GUSK10, GUSK17, UKSK1 in the Acipayam Basin.

GUSK10 geotechnical borehole was drilled in the center of the Acipayam District having 11m depth [29]. Groundwater level is deeper than the depth of the borehole. Soil profile from ground surface to the bottom of the borehole contains 0.4 m vegetable soil and 10.6 m weathered claystone (Figure 5). Soil sample taken at 3 m depth consists of 28.42% sand and 71.58% clay. Soil type of the sample in Unified Soil Classification System [37] is CL. Soil liquefaction is not possible in this borehole location [35] (Figure 7).

GUSK17 borehole was drilled in the center of the Acipayam District having 11m depth. Groundwater level is deeper than the depth of the borehole. Soil profile of GUSK17 borehole, having 11m depth and located in the district center, from ground surface to the bottom contains 0.4 m organic soil and 10.6 m sandy stiff clay. The SPT values in the borehole were bigger than 50 (Figure 5).

UKSK1 borehole was drilled in Uçarı village and 10 m in the lacustrine limestone was cut through the borehole. The groundwater level is 5 m deeper than the ground surface [30]. Lacustrine limestone is weathered and, has pores and karstic cavity (Figure 5). Groundwater discharging through karstic limestone in western area of Uçarı village forms the lake of Uçarı (Figure 6). Weathering, karstic cavity, groundwater pressure in lacustrine limestone and close distance to the earthquake epicenter location had an important influence on the heavy damages of the masonry structures in Uçarı village.
