Evaluation of the fracture strength of different CAD/CAM inlay restorations after accelerated aging^{*}

Selcuk Dent J, 2019; 6: 155-162 (Doi: 10.15311/selcukdentj.456939)

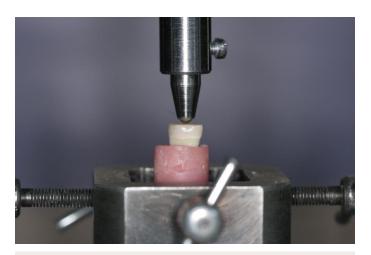
Figure 1. The compressive test during axial loading

After completion of the aging process, all specimens were exposed to axial compressive loading at a crosshead speed of 0.5 mm/min in a universal testing device (TSTM 02500, Elista Ltd, Istanbul, Turkey). A metal sphere (diameter 4.8 mm) was positioned on the center of the occlusal surface and loaded until fracture. The fracture strength data was recorded in Newtons (N) (Figure 1).
