## **A Case Study on Fault Detection in Power Transformers Using Dissolved Gas Analysis and Electrical Test Methods**

This paper presents methodologies for power transformer fault diagnosis using dissolved gas analysis and electrical test methods. These methods are widely used in determination of inception faults of power transformers. Dissolved gas analysis test provides fault diagnosis of power transformers. On the other hand the electrical test methods are used for detection of root causes and fault locations and they provide more specific information about the faults. The aim of this work is to study the faults that are measured and recorded in Turkish Electricity Transmission Company (TEIAS) power systems. For this purpose, four specific cases are considered and analyzed with dissolved gas analysis and electrical testing methods. Three of these cases are defective situations and one case is a non-defective situation. These real cases of measurements have been analyzed with both methods in detail. Assessment results showed that a single method cannot yield accurate enough results in some specific fault conditions. Therefore it was concluded that cooperation of both methods in

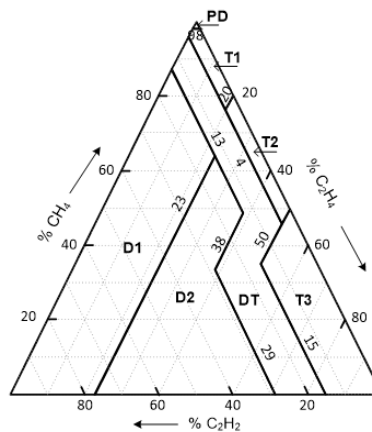
Fig. 1. Duval triangle diagram

Duval triangle method is the graphical representational diagram. It uses only methane, acetylene and ethylene concentrations (in ppm). There is a triangular diagram which is divided into different areas as shown in Fig. 1. Definition of the point of intersection is carried out according to the percentage values of the related gases in the coordinate system. Percentage values of these gases are calculated according to equations given as:

Here,  $x = [CH_4]$ ,  $y = [C_2H_4]$ ,  $z = [C_2H_2]$  represent the ppm values of dissolved gases in oil [6]. Fault types with this method are classified into six classes as partial discharge (PD), low-energy discharge (D1), high energy discharge (D2), low temperature thermal fault (T1), medium temperature thermal fault (T2) and high temperature thermal fault (T3) [8-10].

In addition, the assessment is made by considering Duval Triangle method. First, percentage values of the related gases are calculated for TR-1. Here, ppm values of these gases are  $x = [CH_4] = 204$ ,  $y = [C_2H_4] = 278$  and  $z = [C_2H_2] = 625$ , respectively. The percentage values of gases are found by using the equation 1-3 that will be used in Duval triangle method are  $CH_4\% = 18.43$ ,  $C_2H_4\% = 25.11$  and  $C_2H_2\% = 56.46$ . When these percentage values are located at coordinate system in the Duval triangle diagram in Fig. 1, this fault corresponds to D2 field. In other words it points out that the fault is high energy discharge.

Then the assessment is made by considering Duval Triangle method. First, percentages of related gases are calculated for TR-3. The results are CH<sub>4</sub> % = 7, C<sub>2</sub>H<sub>4</sub> % = 27 and C<sub>2</sub>H<sub>2</sub> % = 66. When these percentages are located at coordinate system in the Duval triangle diagram in Fig. 1, this fault corresponds to D2 field. In other words, it points out that the fault is high energy discharge.

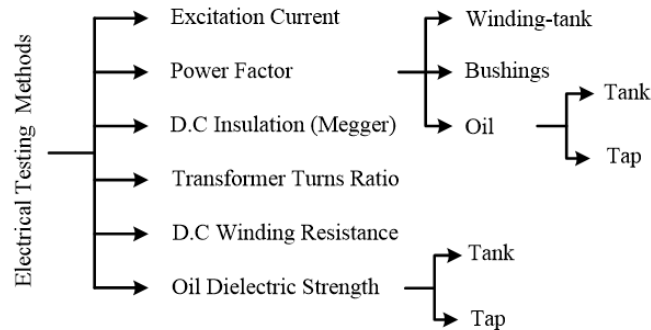
Fig. 2. Classification of electrical tests for power transformers

The classification of conventional field tests applied in power transformers is given in Fig. 2. These test methods are generally consist of excitation current, power factor, DC insulation, turns ratio, DC winding resistance and oil dielectric strength test. Fig. 3 illustrates a photo of a power transformer and the electrical test equipment, which used in carrying out power transformer tests.

All the relevant electrical tests specified in Fig. 2 are applied to TR-2. Excluding the DC winding resistance test, all other test results were found to be within the recommended values. The DC winding resistance measurement test was performed on all windings and tap positions. The primary windings measurement results are found to be within the recommended limits for all the positions. As an example the DC winding resistance results are given in Table 10 at 11<sup>th</sup> and 17<sup>th</sup> tap positions. However, an excessive error rate was calculated from measurement as 33% for the secondary windings. The resistance of X1-X<sub>0</sub> winding is measured higher than the other secondary windings. The reason for this is thought to result from looseness in the connection terminal.

All the relevant electrical tests specified in Fig. 2 are applied to TR-3. All test results were found to be within the recommended values except oil dielectric strength test. Insulation oil dielectric strength test was carried out by breaking down the oil sample taken from main tank at 70 kV instead of 45 kV, which is the limit value for main tank. Thus, insulation of the oil in the main tank is sufficient. On the other hand, in the test that was carried out for the tap oil, it was seen that the oil was broken down at 37 kV. This measurement indicates a fault in the insulation of tap oil because the test result was found to be lower than minimum permissible limit value of 40 kV. So, insulation of it is not sufficient to fulfill the insulation task.

Similarly, all the relevant electrical tests specified in Fig. 2 are applied to TR-4. All test results were found to be within the recommended values. It is concluded that there are no problems with the transformer.

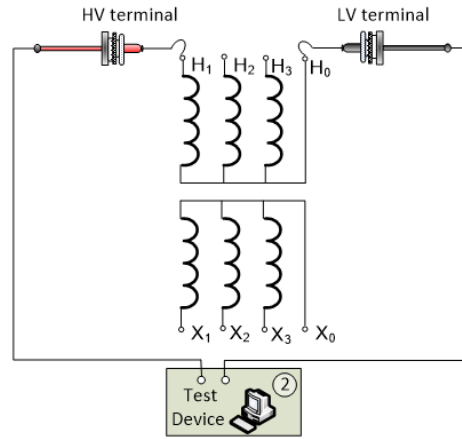
Fig. 4. Principle connection diagram of the excitation current test for three-phase power transformer

The excitation tests are usually performed during (commissioning) an acceptance test, after transformer repair/refurbishment, during preventive maintenance and after fault trips for detecting undesirable conditions in power transformers [16-17]. The aim of this test is to find poor electrical connections, inter-turn short circuits, abnormal core faults and winding problems. It gives information for electrical and mechanical assessment of transformer conditions. Principle of the excitation current test connection diagram is depicted in Fig. 4 for three-phase power transformers. The test is performed on each phase that the current

flows in any winding to excite the transformer in conditions of all other winding are open circuited. It is generally expected to read similar currents for outer limbs of the power transformer when the magnetizing current of the center limb is slightly lower. This test has been an effective method for detecting the transformer faults, nevertheless, it should be noted that the excitation current is much more sensitive and fragile method in some cases. Hence, the test results should be confirmed with turn ratio and DC winding resistance tests.

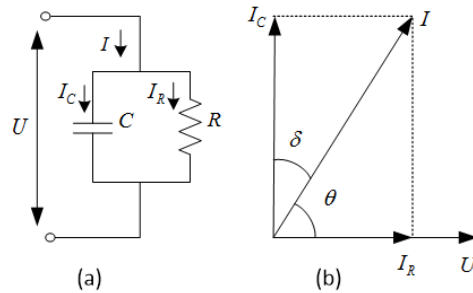
Fig. 5. Power factor (a) equivalent circuit (b) vector diagram

The measurement of power factor is one of the fundamental tests for assessing the condition of the transformer insulation. It is also known as “Tan Delta” or “Dissipation Factor” test. The purpose of this test is to determine the quality of the overall insulation of power transformer such as windings, bushings and oil insulation [17-20]. Equivalent circuit and vector diagrams are illustrated in Fig. 5 for power factor. The power factor ( $PF$ ) is a ratio of the resistive current component ( $I_R$ ) divided to total leakage current ( $I$ ) under an applied AC voltage, which is defined as;

The other definition is called dissipation factor ( $DF$ ), which is the ratio of the resistive current component divided to capacitive current ( $I_C$ ) and defined as below;

The PF measurement demonstrates the dielectric loss on power transformer insulation since the leakage current is related to power loss. If there is a small PF, it means that the tested equipment has good insulation. If PF is high on the other hand, the transformer

insulation tends to have deteriorations and/or contamination because the dielectric losses are largely caused by oxidation, carbonization, water, moisture, carbon, contamination in bushings, windings and liquid insulation etc.

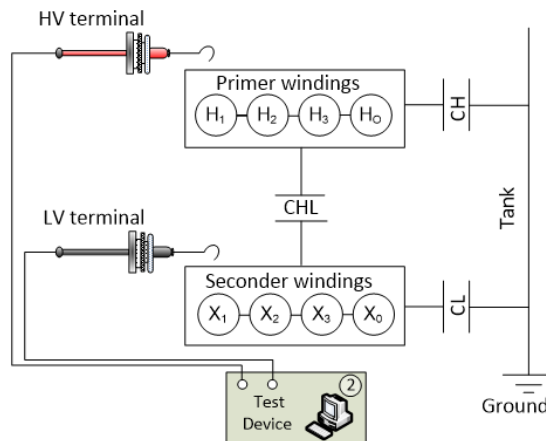
Fig. 6. Principle connection diagram of PF test for three-phase power transformer

The measurement can be done between the windings and also between the windings and the tank. The PF test connection diagram is depicted in Fig. 6 for three-phase transformer. As seen from this figure, the high voltage winding to ground capacitance, the low voltage winding to ground capacitance, the high voltage to low voltage winding capacitance are labeled as CH, CL and CHL, respectively.

The results of overall PF tests on power transformers indicate the insulation condition of the windings barriers, tap changers, bushings and oil. The limit values are determined by TEIAS according to relevant standards. The modern oil-filled power transformers should have power factors of 1 % or less, for CL, CH and CHL as well as bushings insulation. The power factor of the oil insulation system shall not exceed 0.5 % at 20°C.

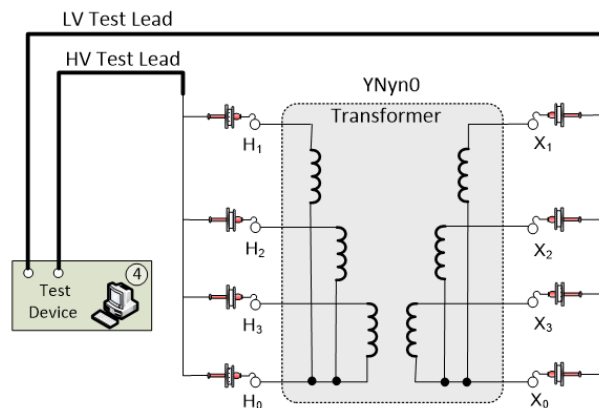
Fig. 7. Principle connection diagram of TTR test for three-phase power transformer with YNyn0 configuration.

The transformer turns ratio (TTR) test is performed on all tap positions of every phases at no-load condition. The aim of the test is to obtain information on whether any connection problem and/or short circuit in the transformer windings exist [17-18, 21, 24]. The measurement principle of the test is based on applying alternating current (AC) low voltage to one of the primary windings and measuring the induced voltage of the related secondary winding later. Thereby, the ratios are calculated as the applied voltage value divided by the induced voltage reading and also the measurements are repeated in all phases and at all tap positions, sequentially. The TTR devices might be used to conduct this test and can be seen in Fig. 3 labeled with number 4. It should be noted that the principle of TTR test connection diagram depends on vector configuration and right polarity of the correspond windings, as an example, the TTR test connection diagram for three-phase power transformer with YNyn0 configuration is shown in Fig. 7.

In ideal three-phase transformers, turns ratios must be identical for all phases, however, the measured value may show a deviation from the ideal turn ratio of the transformer due to construction error, measurement error, device sensitivity etc. The percentage of the deviation can be calculated as;

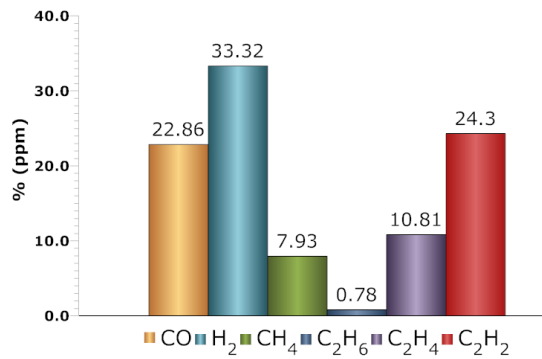
Fig. 8. Key gases and their percentage values for TR-1

The assessment is made by using the Key Gas method: The percentage of each combustible gas is calculated and interpretation is done by the gas that has the dominant percentage value. In this case, amount of total combustible gas is found to be 2572 ppm. From this information, the percentages of other combustible gases are calculated and are shown in Fig. 8.

It is obviously determined from the calculated percentage values of key gases that great amount of hydrogen and acetylene, small amount of methane and ethylene gases are formed. In analysis results, higher acetylene content indicates that arcing occurred in transformer. Also, rise in ethylene content shows that the oil is carbonized and broken down at high temperatures. This verifies the fact that fault is facilitated high energy discharge. In this type of fault, partial discharges occur because of roads or bridges that are formed on the surface of insulation materials. As a result of partial discharge there would be an increase in the amount of hydrogen gas. By looking at the assessment results, the principal gas is acetylene and its percentage value is 24.3. All these assessments show that the condition corresponds to a high energy discharge (arc, spark) fault. It is also observed that hydrogen increases since in the formation of acetylene the hydrogen gas is released.

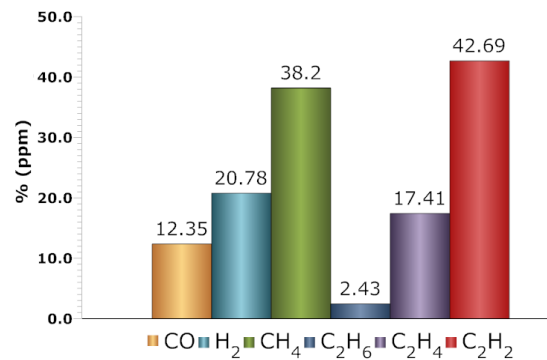
Fig. 9. Key gases and their percentage values for TR-3

The assessment made by considering the Key Gas method, DGA test was conducted by taking the oil sample from the main tank and high voltage cable box (Domes) of the TR-3. The DGA test results of the sample that was taken from the main tank of transformer are found to be in normal range. However, the samples that were taken from the high voltage cable connection boxes contain considerable amount of ethylene and, especially acetylene gases. Gas content of Dome-A is given in Table 4 as an example. In the assessment, it can be concluded that the principle gas is acetylene. Its percentage value is 42.69%. Key gases and their percentage values for TR-3 are illustrated in Fig. 9. Also, a large amount of

methane as a secondary indication of overheating and arc is observed. All these considerations show that the fault corresponds to arc and/or high energy discharge.

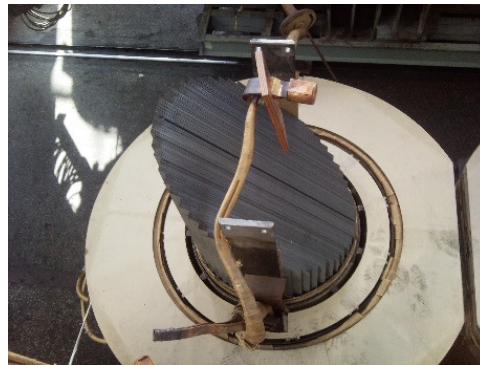
An analysis of the DGA test results in accordance with Key gas and Duval triangle methods for TR-1, it is deduced that the failure is high energy discharge. Furthermore, excitation current, PF, DC insulation and the TTR tests indicate an abnormal condition for TR-1. The excitation current from primary H<sub>3</sub>-H<sub>0</sub> winding and for secondary X<sub>3</sub>-X<sub>0</sub> winding cannot be measured. Likewise in the applied PF test, insulation could not be determined between winding-winding and winding-tank. The DAR value of primary/secondary insulation could not be identified in the DC insulation test. In addition, it was found in the

TTR test that there was a reduction in turns ratio of  $H_3-H_0/X_3-X_0$  for TR-1. In conclusion, when all the tests are evaluated together; the fault has been observed in the primary and secondary windings of third phase. These results give rise to the thinking that there is a short circuit in the third phase. So, when the transformer was opened in the repair center, fault was detected where it was expected. Fig. 10 illustrates a photo taken from the top in the repair service for TR-1. Primary (outer ring) and secondary (inner ring) coils and their paper insulation on one leg of the core (innermost silica sheets) are seen in the figure. In the physical testing of third phase of the transformer, the insulation between the primary, secondary and core was found to be deteriorated. In addition, the windings were in contact with the core. Therefore, the transformer was taken to the maintenance service for required repair and maintenance tasks.

Fig. 10. A photo of faulty part of the TR-1 in the repair service

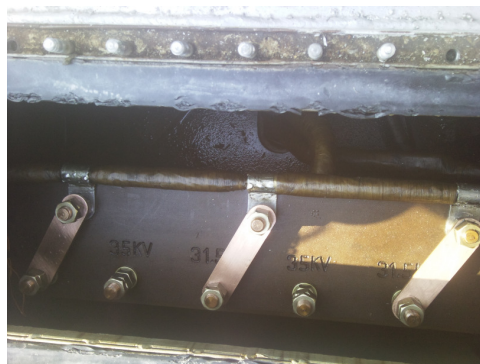
All of the DGA contents were found to be within the recommended limit values for TR-2. So, it can be concluded that there is no fault in the transformer for this case according to the DGA contents. Excluding the DC winding resistance test all other test results were found to be within the recommended values. In the applied DC winding resistance test, an excessive error rate (33% for the secondary windings) was obtained by calculations and measurements. The resistance of  $X_1-X_0$  winding is measured to be higher than the other secondary windings. This suggests that there is looseness in windings or in connection terminal of the  $X_1-X_0$  windings. In fact, as a result of physical inspections, looseness was detected in the connection terminal of the secondary  $X_1-X_0$  winding. Fig. 11 shows a photo of the loose connection failure for this transformer. After the required maintenance, the values were measured in the desired range.

Fig. 11. A photo of loose connection failure for the TR-2 in the repair service

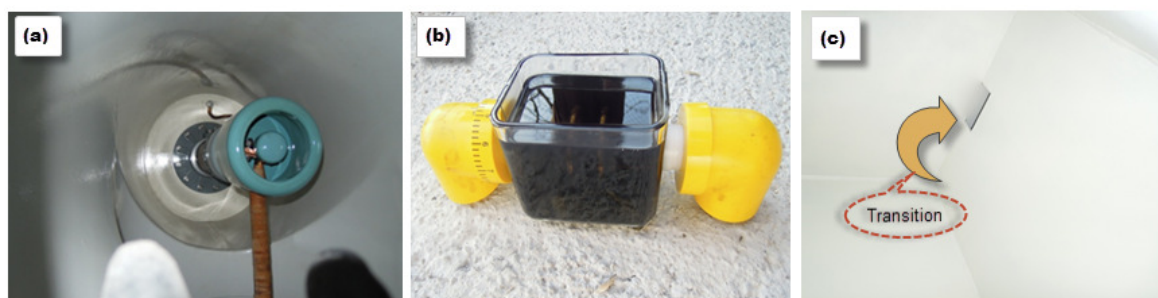
In interpretation of the DGA test results in accordance with Key gas and Duval triangle methods, it is deduced that the failure is high energy discharge for high voltage cable boxes

(Domes) of the TR-3. The high level of combustible gas amount indicates the presence of an arc for the oil in the cable boxes. After this conclusion, HV cable box was opened, the oil was poured and the examinations were made. As seen from the photo in the Fig.12 (a) no trace of arc was observed and oil was not carbonized in the dome. Although high amount of combustible gases were observed in the cable box, it is concluded they were not formed in there and an explanation is needed for this situation. However, it was observed that tap changer reserve oil was carbonized and broke down at a low voltage level as 37 kV in the oil dielectric strength tests. The carbonized oil in tap changer reserve is shown in Fig. 12 (b). Therefore it is almost certain that acetylene was produced because of tap oil had been exposed to arc gained. These combustible gases seen in the HV cable box are thought to be leaked from the tap-changer reserves. It is judged that there is a transition between the tank and the tap changer reserves which should be separated normally. As shown in Fig. 12 (c) an improper design was observed during physical examinations, which has a transition between the main tank and tap changer reserves. It is observed that combustible gas occurs during the tap changing and these gases are transferred to the cable box via diffusion from common reserve tank. As a result, gas formation in the high voltage cable box was attributed to manufacturing error, specifically to the transformer design. The issue has been resolved by closing the transition area between the common reserves and making the necessary modifications. After these operations, the transformer was inserted into service and it is observed that the transformer have been operated without any abnormal situation.

Fig. 12. a) High voltage cable box, b) Carbonized tap changer oil  
c) Transition area between the reserves
